Technical Service Bulletin

94 Rear lights do not switch from bumper to hatchgate

94 20 23 2047618/4 April 20, 2020. Supersedes Technical Service Bulletin Group 94 number 19-03 dated February 7, 2019 for reasons listed below.

Model(s)	Year	VIN Range	Vehicle-Specific Equipment
Q7	2017 - 2021	All	Not Applicable

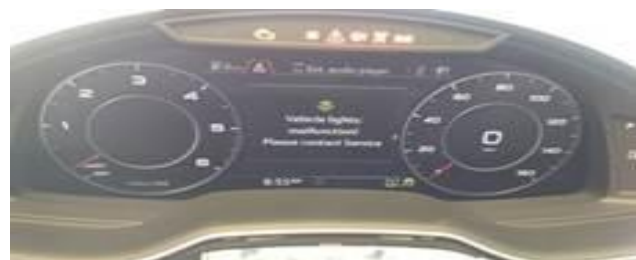
- When the rear lid is closed, the lights in the rear bumper do not switch over to the main lights on the rear lid.
- The error message “Vehicle lights: malfunction! Please contact Service” intermittently appears in the driver information system (Figure 1).
- All of the rear light bulbs are fully functional. None are found to be faulty or incorrect.

Figure 1. Error message.

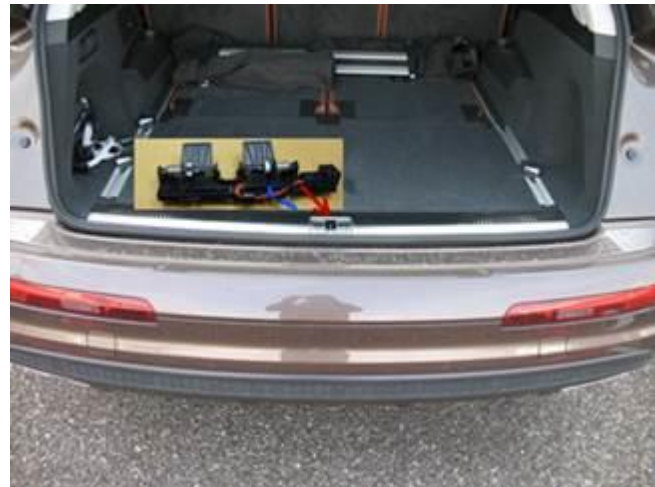
This condition may be caused by incomplete actuation of the rear lid closed sensor G525/G526 due to debris in the switch mechanism (Figure 2).

Figure 2. Rear lid closed sensor.

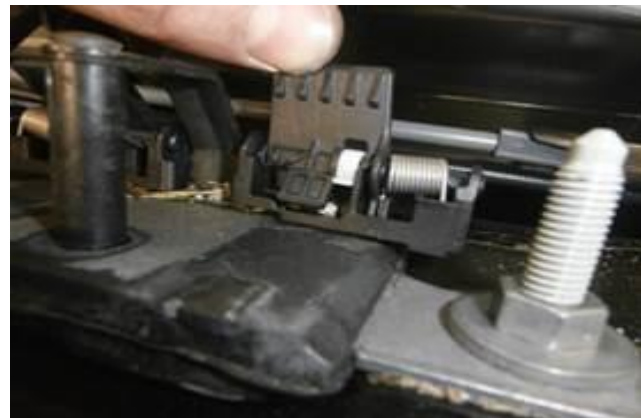
Mounted to the base of the rear lid striker is the G525/G526 rear lid closed sensor. Due to its position, debris that enters the striker housing can get caught in the switch mechanism and cause incomplete switch actuation (Figure 3).

Figure 3. Debris in the rear lid closed sensor.

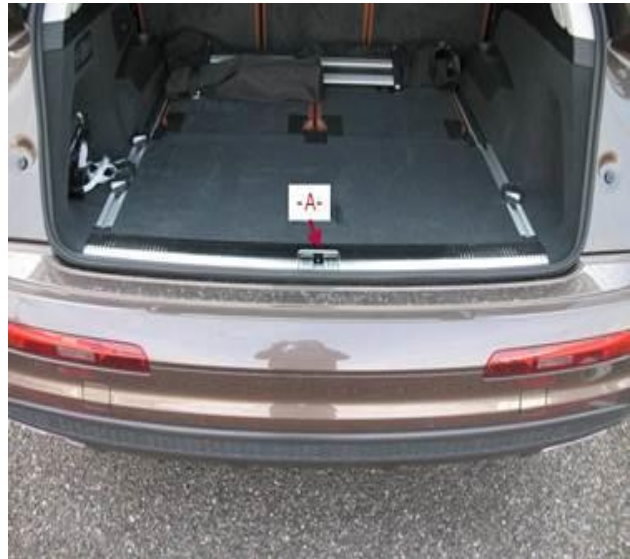
Figure 4. Striker cover opening.

1. Press down the striker cover on the loading sill cover -A- (Figure 4).

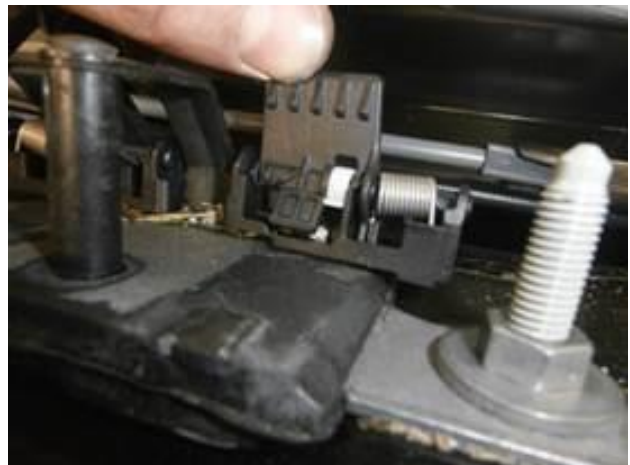
Figure 5. Debris trapped in the rear lid closed sensor.

2. If debris is found to be obstructing proper switch activation/deactivation, activate the switch paddles using your fingers and remove the debris. Using compressed air is effective.

Then check the measuring values for the G525 and G526 switches and replace the rear lid closed sensor, if the malfunction persists. Only the improved rear lid closed sensor with the protective enclosure is available.
