17-20-01TT - Engine Oil Leak from Oil Pan or Transmission (Bellhousing) Area

Release date: 04/17/2020

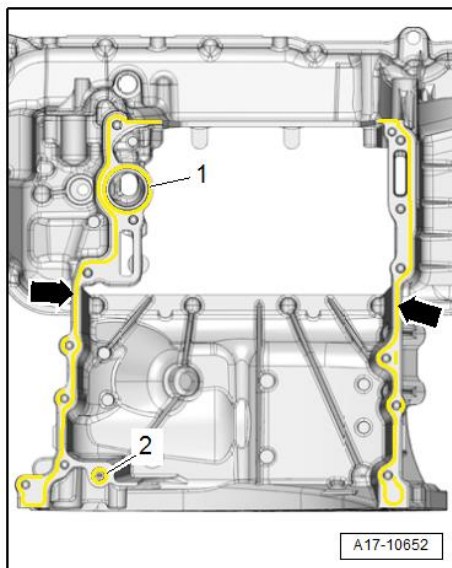
Oil leaking.

Check torque on the upper oil pan (sump) bolts. Specifically, the 3 long bolts near the starter that go through the oil pump. A T45 fastener is used. Check for oil on the 3 long bolt heads to further indicate the source of the leak. Verify that oil pan sealant was routed correctly on the oil pan.
