00-18-07 - By-Pack at Delivery (U.S. Only)

Release date: 4/14/2020

Revision Table			
Instance Number	Published Date	Version Number	Reason For Update
2036935/17	04/14/20	00-18-07	To include additional models and model year applicability.
2036935/16	03/19/20	00-18-07	Update metadata selection adding new model year.
2036935/1	6/4/14	V001405	Original publication.

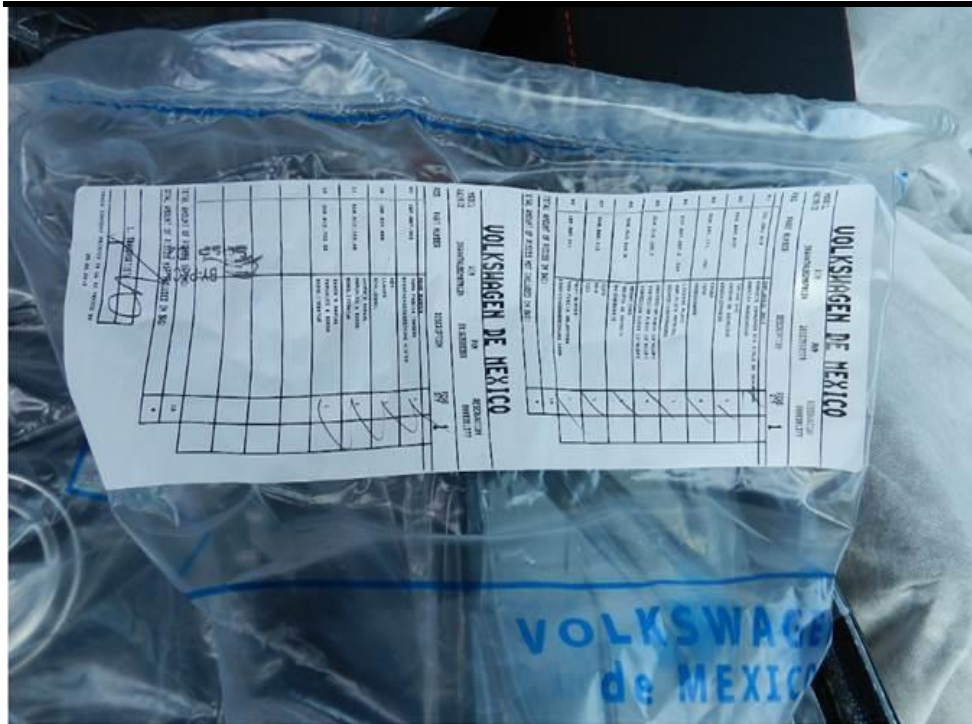
By-Pack is the term used to describe the bag that is delivered with the vehicle that contains the parts to be installed at PDI, i.e. Wheel Center Caps, Lug Caps, Wiper Blades, Etc. Figure 1.

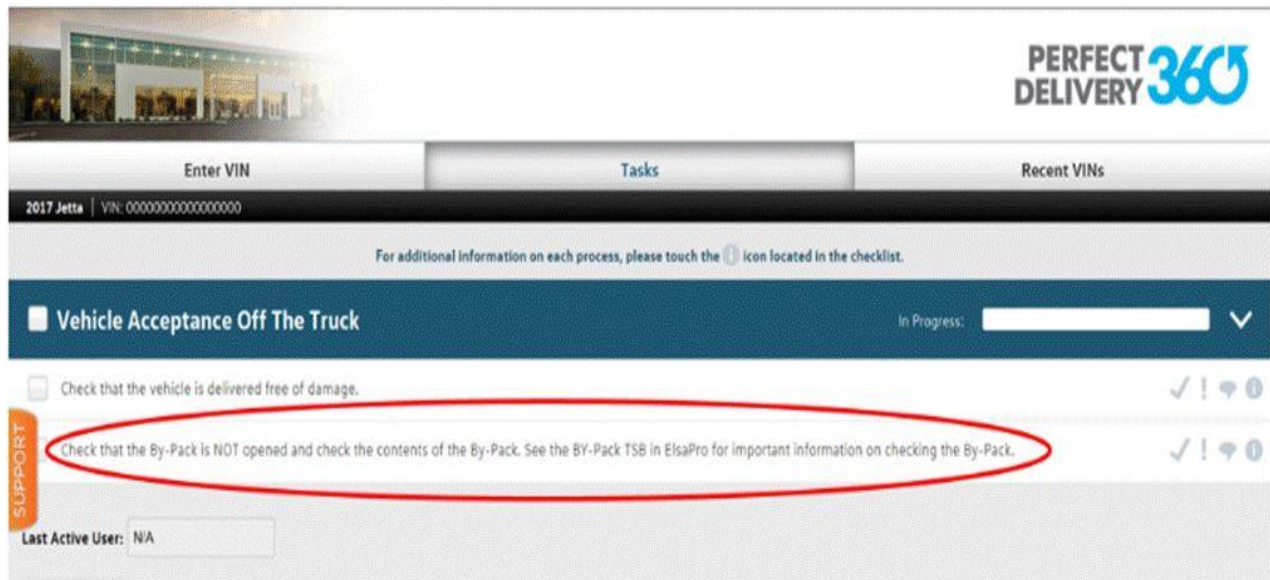
Figure 2.

Please note that the ePDI form has been updated to include the By-pack condition and content check at vehicle acceptance off the truck (Figure 2).

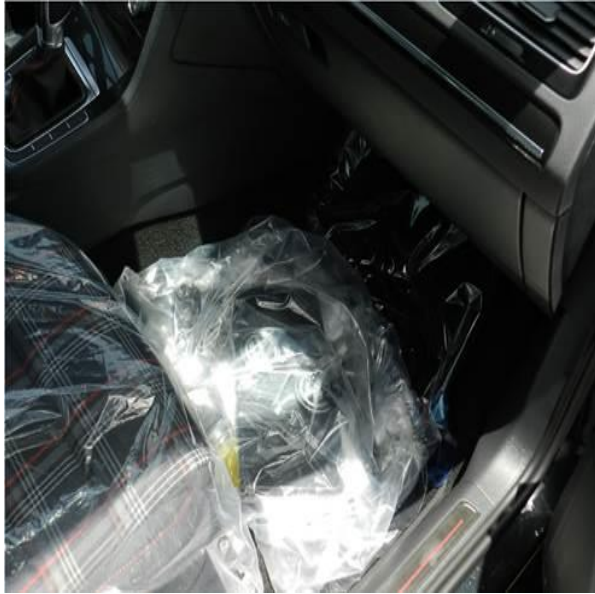
Figure 5. By-pack Location for cars produced in Mexico

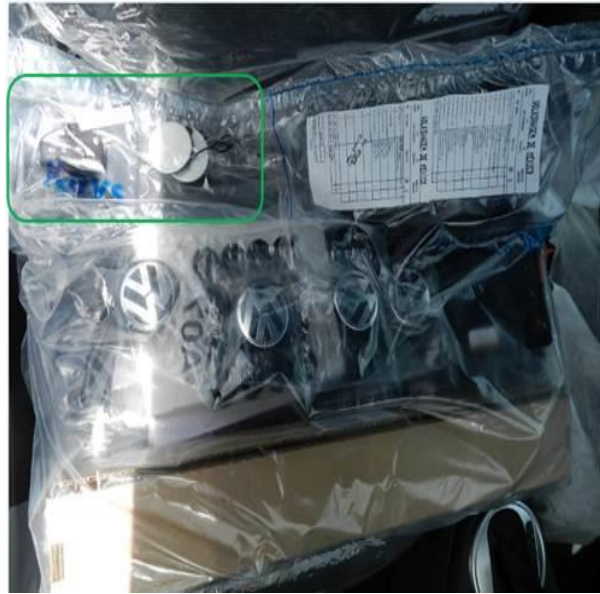
Figure 6. Separation pouches for key(s) tow hook cover, etc.

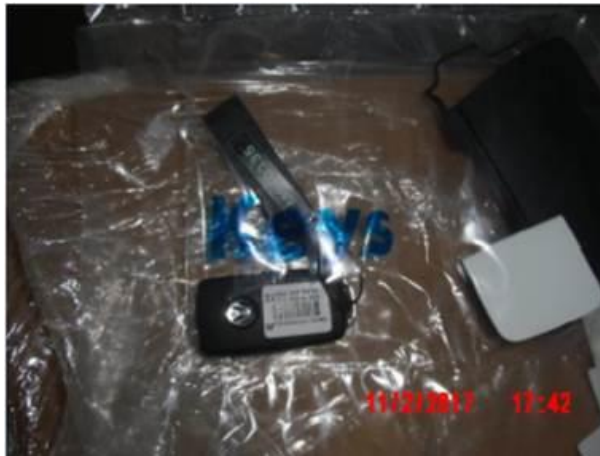
Figure 7. One key in By-pack for cars produced in Mexico.

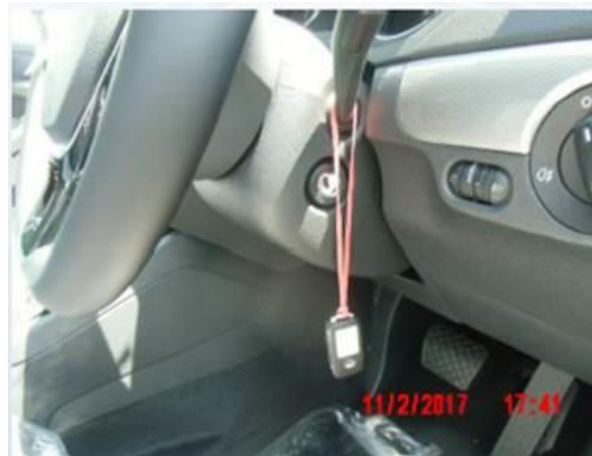
Figure 8. One key tether to the wiper stalk for cars produced in Mexico.

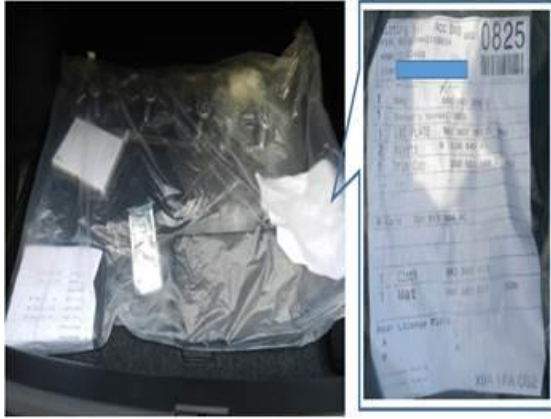
Figure 9. Passat By-pack located in the luggage compartment

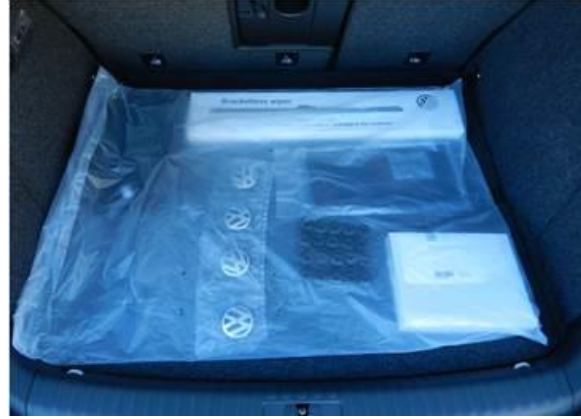
Figure 10. Tiguan Limited By-pack located in the luggage compartment

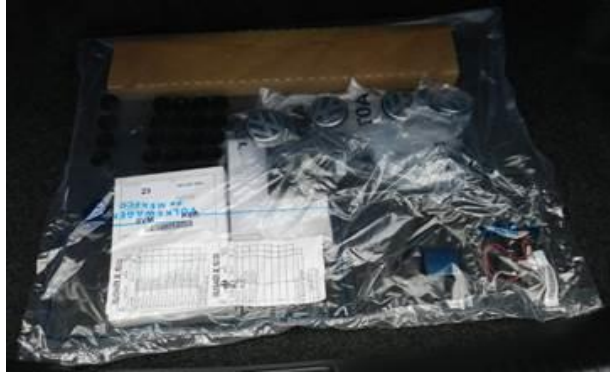
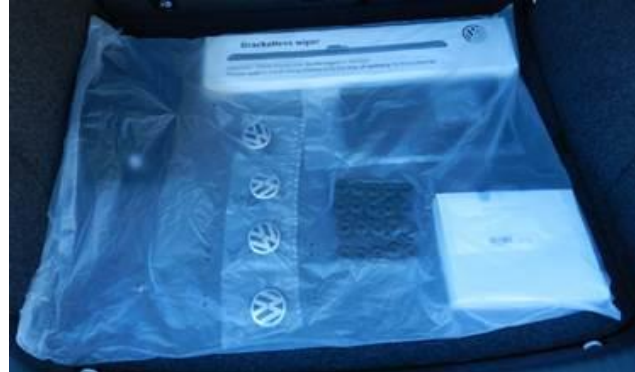
Best Practice - At PDI **BEFORE** opening the By-Pack spread out the By-Pack on a work bench or table exposing all the contents as best as possible and take a picture of the front and rear of the By-Pack (Figures 11 and 12). Make sure that the components labels with VIN is captured in the photo and check for missing components during this time.
