**Subject: GHG14 DETROIT™ DD13® with Two-Box Aftertreatment Software
Reprogramming**

Models Affected: GHG14 DD13 Engines

Subject: **Field Service Campaign D20M1**

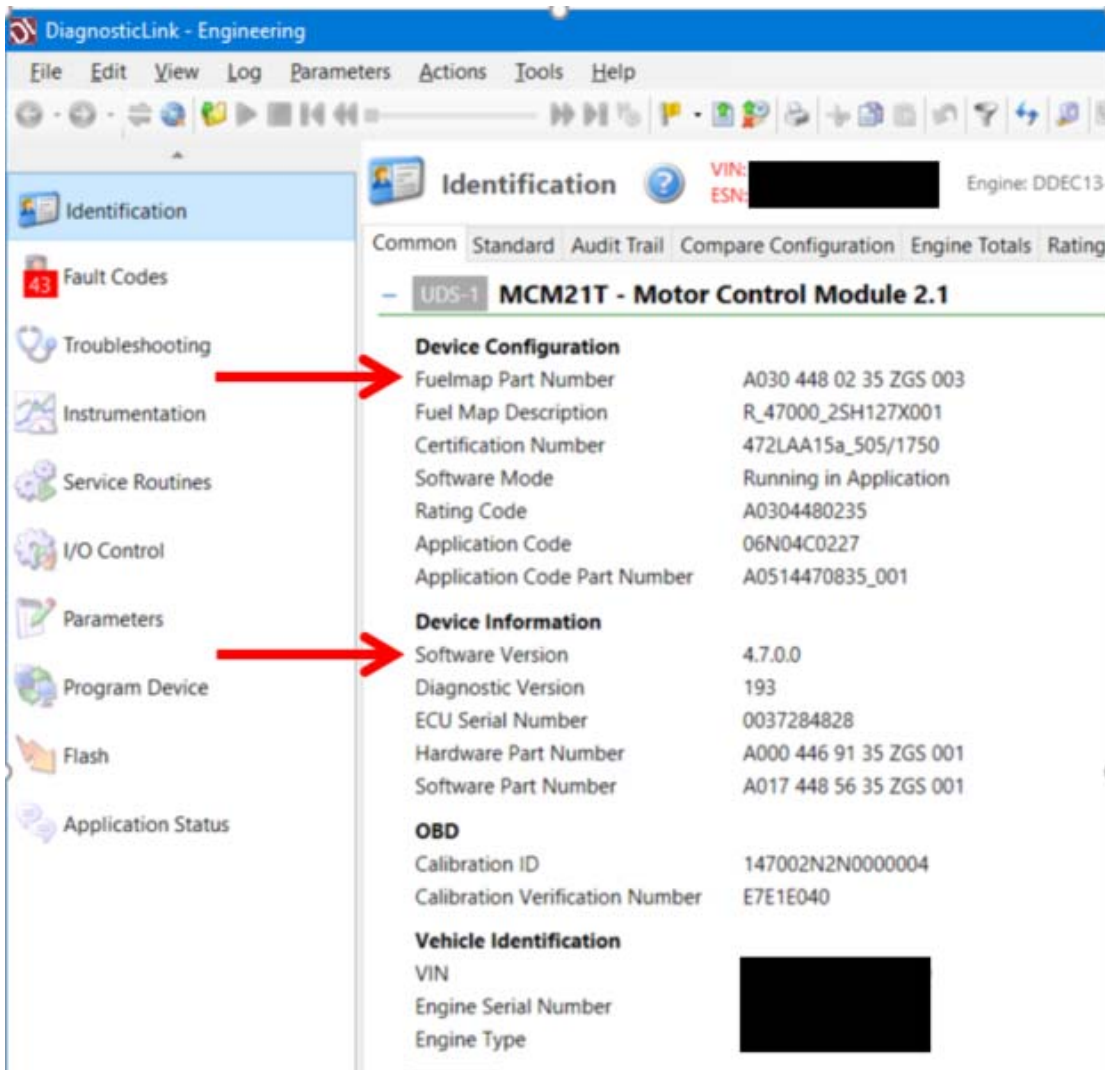
Figure 1 – DiagnosticLink® Identification Screen

6. Is the **software** level for all modules less than, equal to, or higher than the software levels listed in step 5? For example in Figure 1, MCM software 4.7.0.0 with ZGS 003, which equal to required software of 4.7.0.0, but less than the required ZGS 005.
 - a) If less than the required software levels, proceed to step 7.
 - b) If equal to required software, but ZGS is less than 005, proceed to step 7.
 - c) If higher than the required software levels, no programming is necessary. Proceed to step 13.
7. Select the “Program Device” option along the left side of the DiagnosticLink® screen.
8. Select the “Add” button in the upper right corner of the DiagnosticLink® screen and enter the engine serial number. Then click the “Connect to Server” button in the bottom right corner of the DiagnosticLink® screen. See Figure 2.
