Service Bulletin

Bulletin No.: 20-NA-047

Subject: Front or Rear Crankshaft Oil Leak, Malfunction Indicator Lamp (MIL) Illuminated - DTC P1101 Set

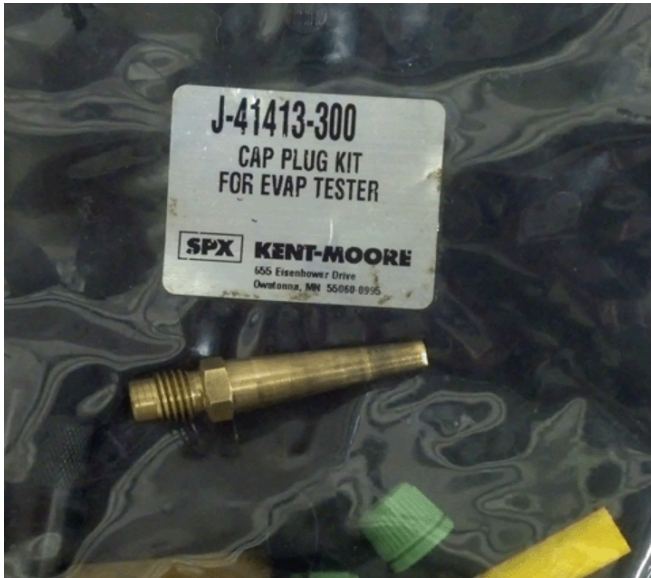
3416804

EEST hose adaptor

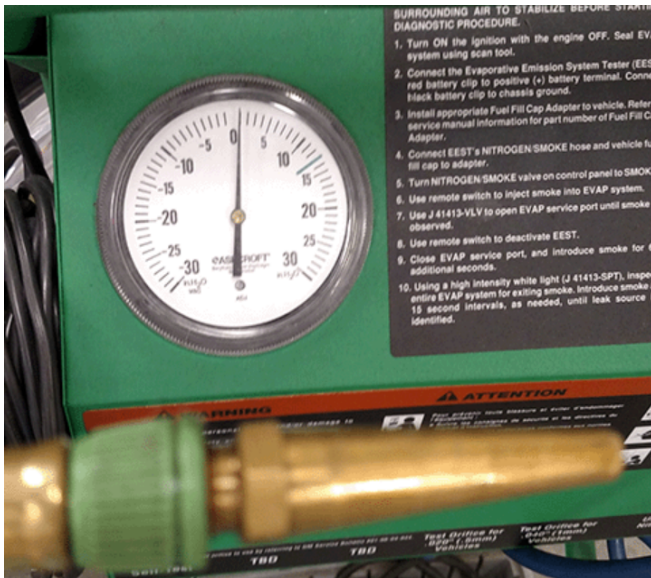
4573240

EEST Gauge at 0 reading

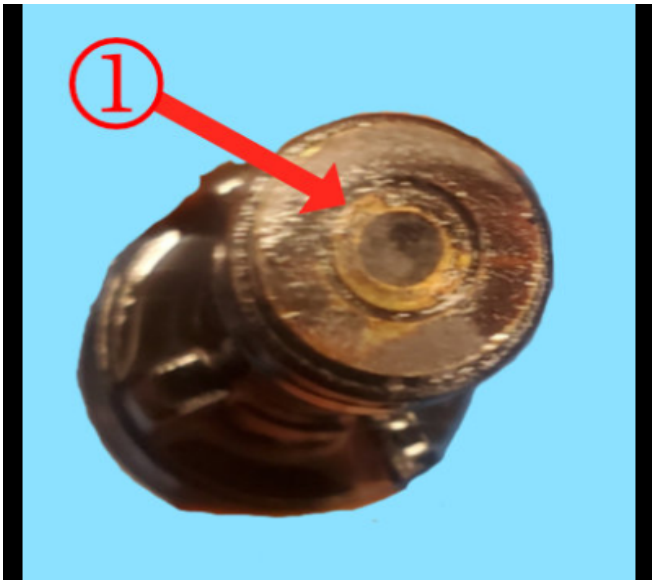
5513764

If diagnosing for oil leaks and/or DTC P1101 with no engine oil leaks and excessive positive crankcase pressure exists, an obstructed PCV orifice (1) would be suspect requiring a PCV orifice replacement.

Remove the camshaft cover and remove the PCV orifice and inspect for blockage. Replace the orifice as necessary along with the camshaft cover gaskets. Make sure the camshaft cover does not have any blockages in the PCV passages.
