Service Bulletin

Bulletin No.: 20-NA-062

Subject: Intermittent Slips in Reverse and/or No Reverse

Brand:	Model:	Model Year:		VIN:		Engine:	Transmission:
		from	to	from	to		
Chevrolet	Colorado	2019	2020				MYB
GMC	Canyon

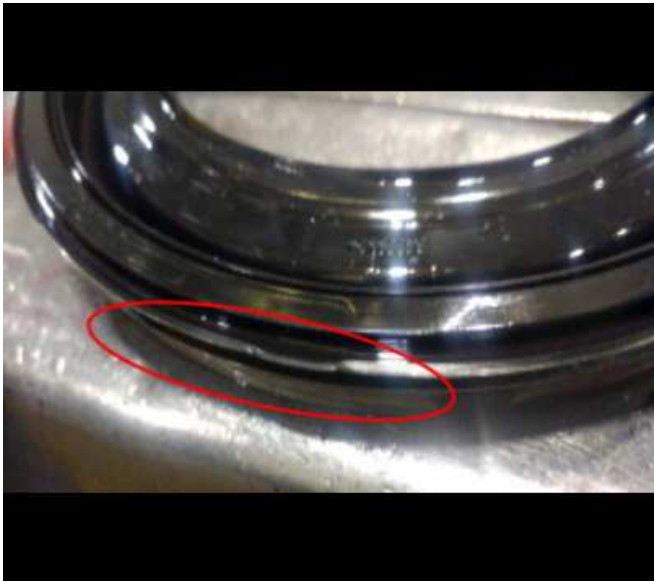
Involved Region or Country	North America
Condition	Some customers may comment that the transmission intermittently slips and/or does not engage when shifted into reverse.
Cause

<p style="text-align: right; font-size: small;">5539394</p> <p>This condition may be caused by a rough finish on the center support housing damaging the low-reverse piston seal.</p>
Correction	Replace the reverse piston seal and the center support.

Refer to *Center Support, Output Carrier and Output Shaft Removal (6L50)* and *Center Support, Output Carrier and Output Shaft Installation (6L50)* in SI.
