# Service Bulletin

Bulletin No.: 20-NA-065

**Subject:** Information on Malfunction Indicator Lamp (MIL) Illuminated with Multiple Fuel Trim and/or Oxygen Sensor Codes Set

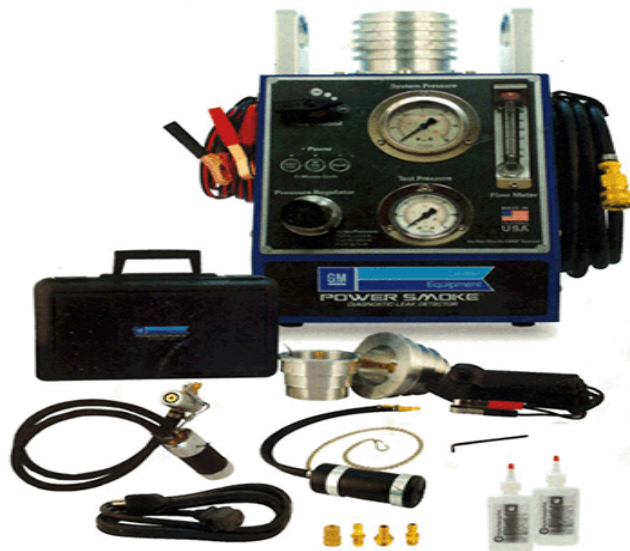
5418222

**Note:** The adapters may vary as the tool evolves.

GE-52250: Variable Pressure Leak Detector
