Service Bulletin

Bulletin No.: 20-NA-066

Subject: Malfunction Indicator Lamp Illuminated with One or More Glow Plug Control DTCs Set

Brand:	Model:	Model Year:		VIN:		Engine:	Transmission:
		from	to	from	to		
Chevrolet	Silverado 1500	2020	2020			LM2	
GMC	Sierra 1500

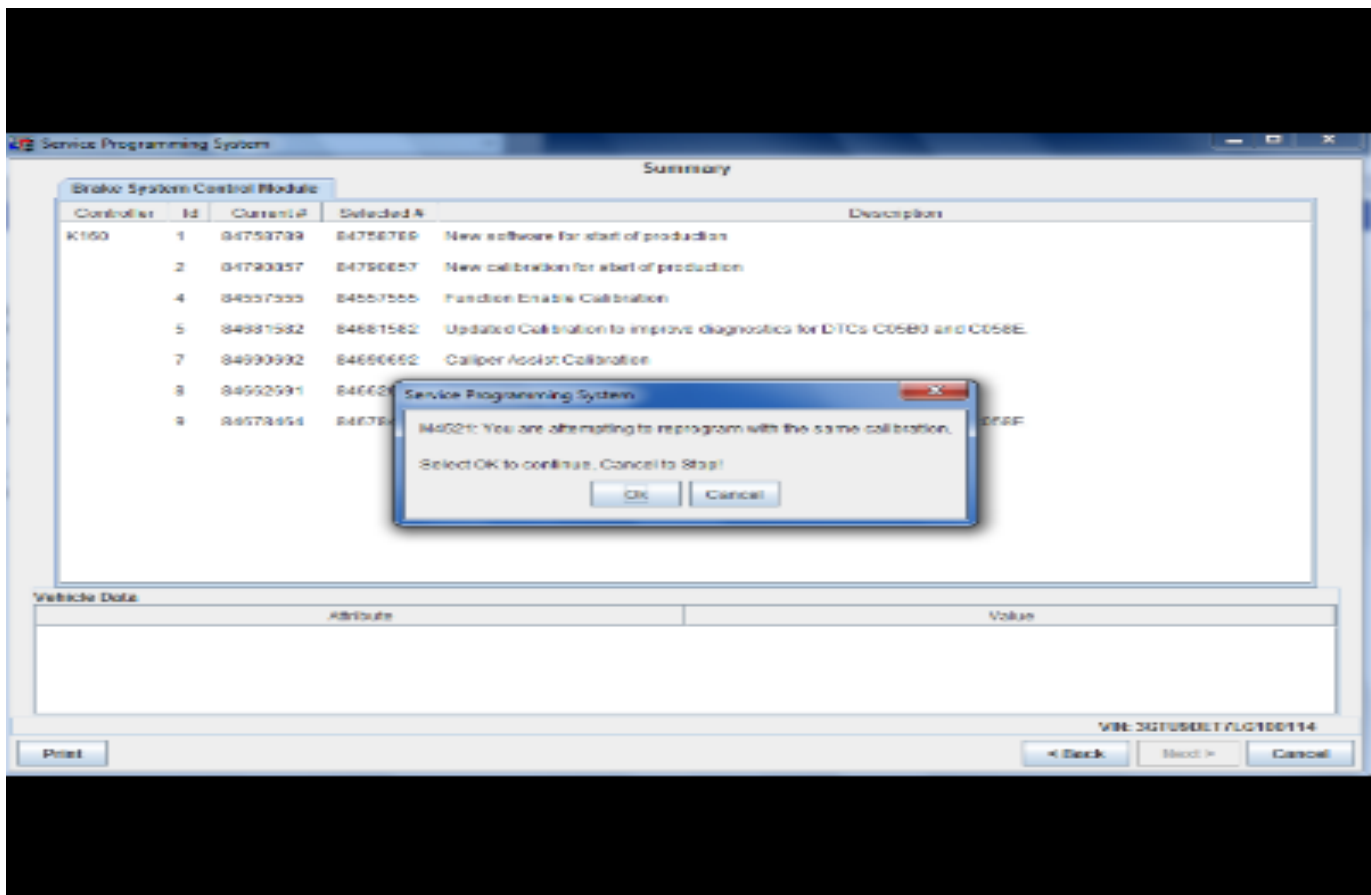
Important: If the Same Calibration/Software Warning is noted on the SPS screen, select OK and follow screen instructions. After a successful programming event, the WCC is located in the Service Programming

System dialogue box of the SPS Summary screen. No further action is required. Refer to the Warranty section of the bulletin.
