STAR ONLINE PUBLICATION

Case Number: S2008000004

Symptom/Vehicle Issue: Left Side Steering Wheel EVIC And Radio Switches Are Inoperative

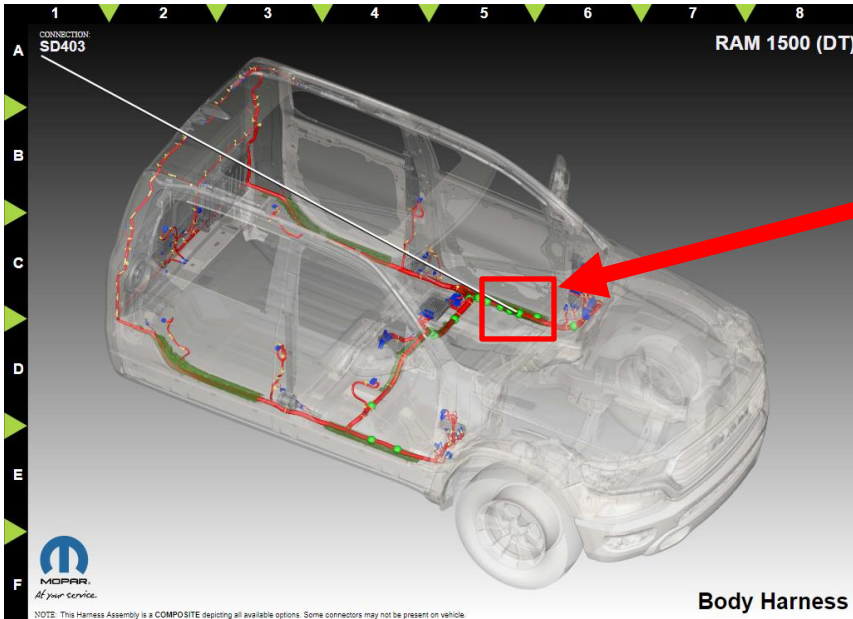
SD403 Under
Drivers Door Sill

It's been found that the D403 OG/DB LIN circuit for the left steering wheel switches has an open circuit at the SD403 Splice. The splice is located under the driver's door sill. Remove the protective heat shrink around the splice and inspect for a loose and/or corroded connection. DTC's U116A and U1446 are commonly set when this fault occurs.

D403 OG/DB
LIN Circuit

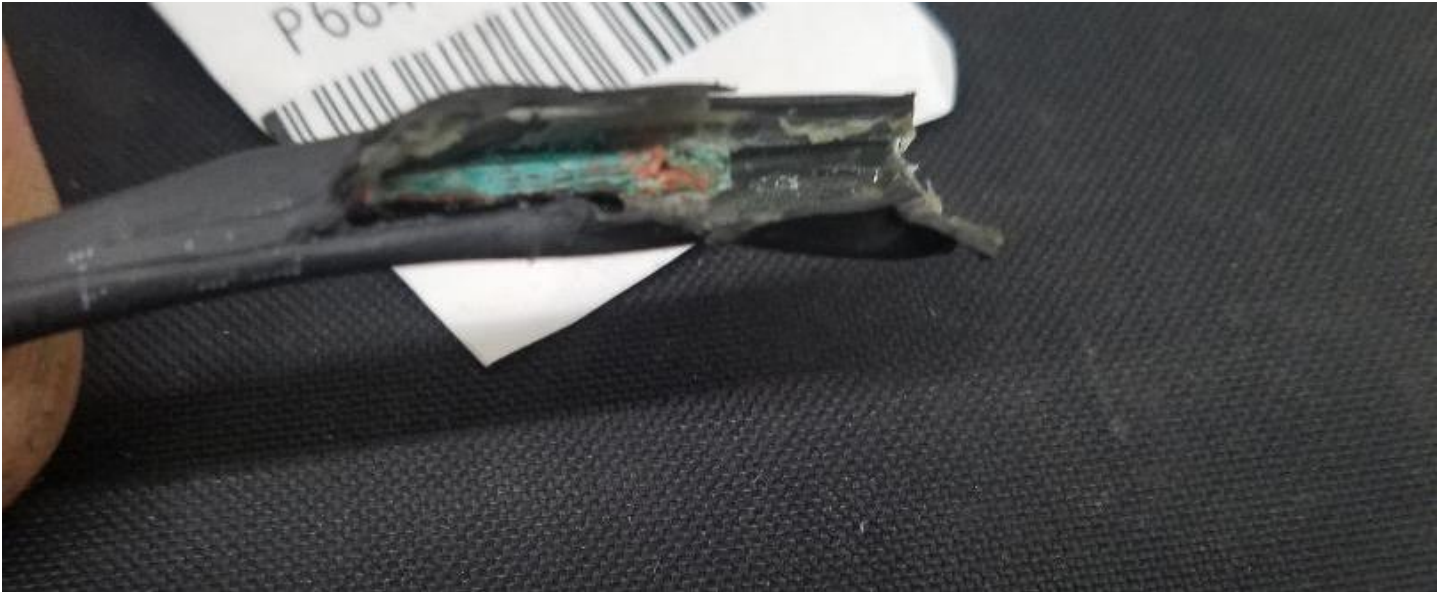
Corroded Splice SD403

Repair: Clean and repair the circuits using standard procedures. Make sure to utilize heat shrink in your repair to protect the splice from future corrosion.
