STAR ONLINE PUBLICATION

Case Number: S2008000030

Symptom/Vehicle Issue: Overhead Console, Liftgate, Dome Light And Sunroof Controls Inoperative

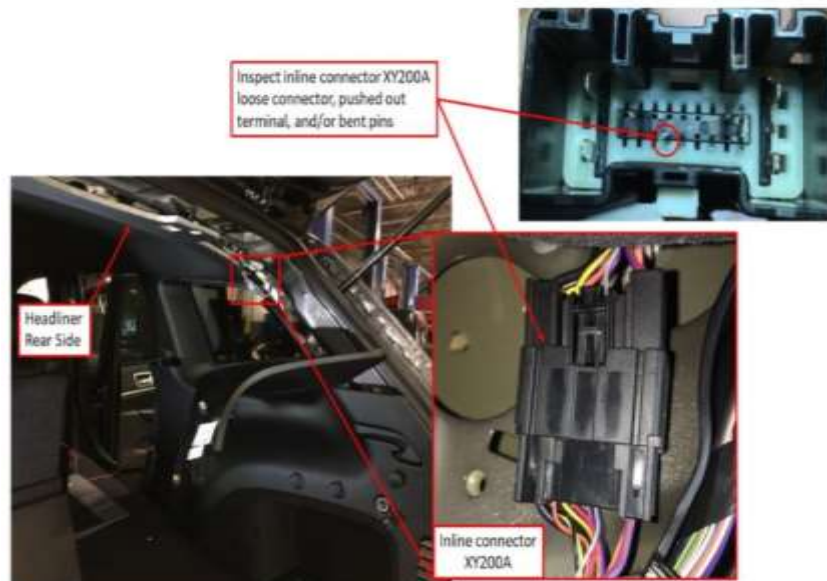
Fig 1

Customer complaint/ technician observation: The customer may complain that the Overhead console/liftgate/dome lights and sunroof controls are INOP. Technician observed when scanning the modules that the vehicle did not set any DTCs.

Repair Procedure: Check the inline connector XY200A at the rear of the headliner right side, and inspect for loose connector and/or pushed out terminals or bent pins. See example below. Fig 1, 2, and 3.
