NUMBER: 08-036-20

GROUP: 08 - Electrical

Auto High Beam Feature Inoperable

2018 - 2019 (M6) Jeep Compass

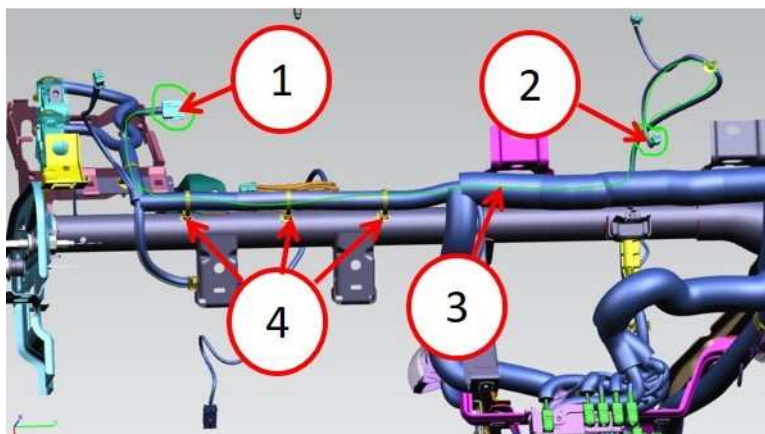
Fig. 2
Jumper Wire Harness Routing

- 1 – HVAC Control Module Connector D3828A
- 2 – Sun Sensor Connector D1561A
- 3 – Headlamp Wire Harness
- 4 – Tie Straps

7. Route the jumper wire harness from the sun sensor connector D1561A, to the Heating, Ventilation and Air Conditioning (HVAC) control module connector D3828A behind the Instrument Panel (IP) (Fig. 2) .

8. Secure the jumper wire harness to the headlamp wire harness with three 150 mm length (6 in.) by 3 mm (.011) wide tie straps (Fig. 2) .
9. Connect the other end of the jumper wiring harness to cavity number one (F944) on the HVAC control module connector D3828A (Fig. 3) .

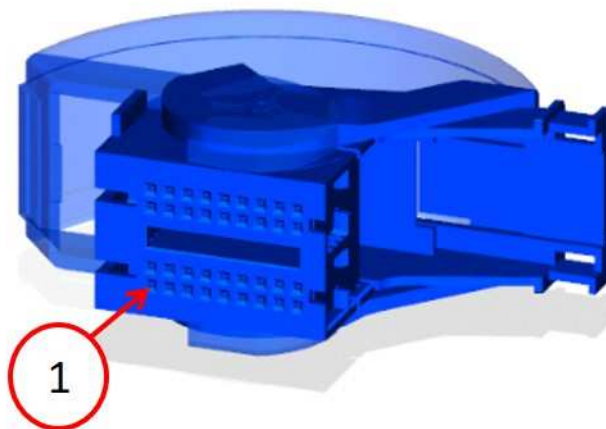
Fig. 3
HVAC Control Module Connector D3828A

- 1 – HVAC Control Module Connector Cavity One (F944)
