# Service Bulletin

Bulletin No.: 16-NA-318

**Subject: Hard to Steer in Colder Temperatures and/or Knocking/Clicking Noise Heard**

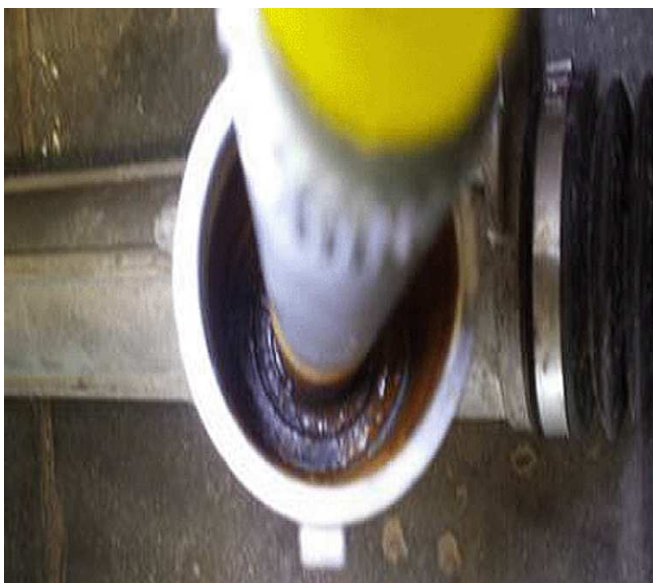
4355408

Check for water intrusion and corrosion at the power steering gear pinion housing. A small amount of rust spots are normal such as one or two small red rust spots.

If water intrusion and/or more than 1 or 2 rust spots is detected, replace both the intermediate steering shaft boots (seals) and the steering gear.
