Service Bulletin

Bulletin No.: 16-NA-405

Subject: Poor Engine Performance in Extremely Cold Weather Conditions, PCV Bypass Hose and Charge Air Cooler Icing for LUV Engines, Malfunction Indicator Lamp (MIL) Illuminated - DTC P0299, P0236, P2227, P00C7 Set

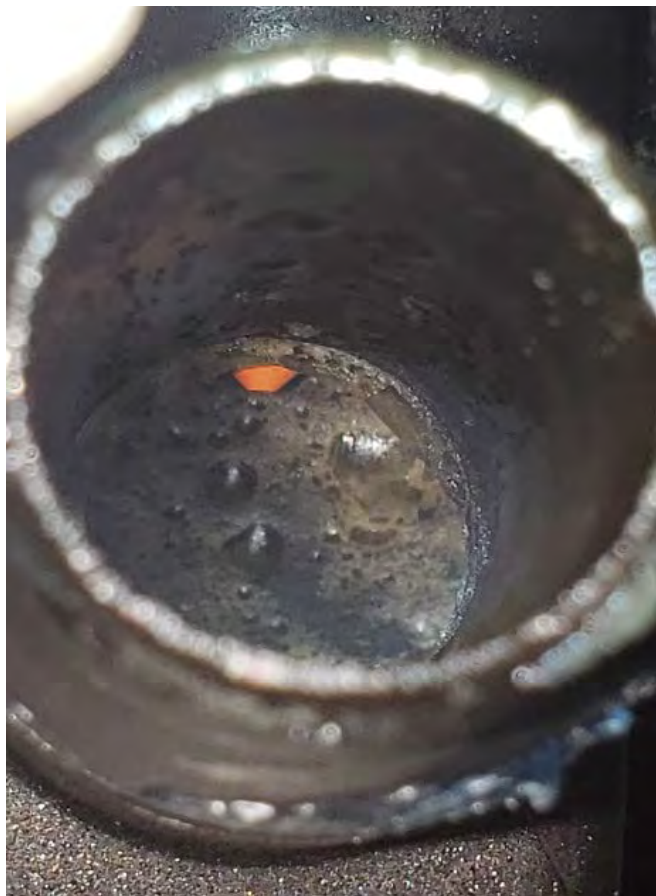
5286434

2. Inspect the vacuum ports of the intake manifold for ice accumulation.

4. Clean any ice/sludge/water/carbon out of the PCV pipes/hoses, the PCV nipple on the intake manifold, the PCV intake runners and the orifice between the #2 and #3 intake ports.
5. Install the intake manifold.

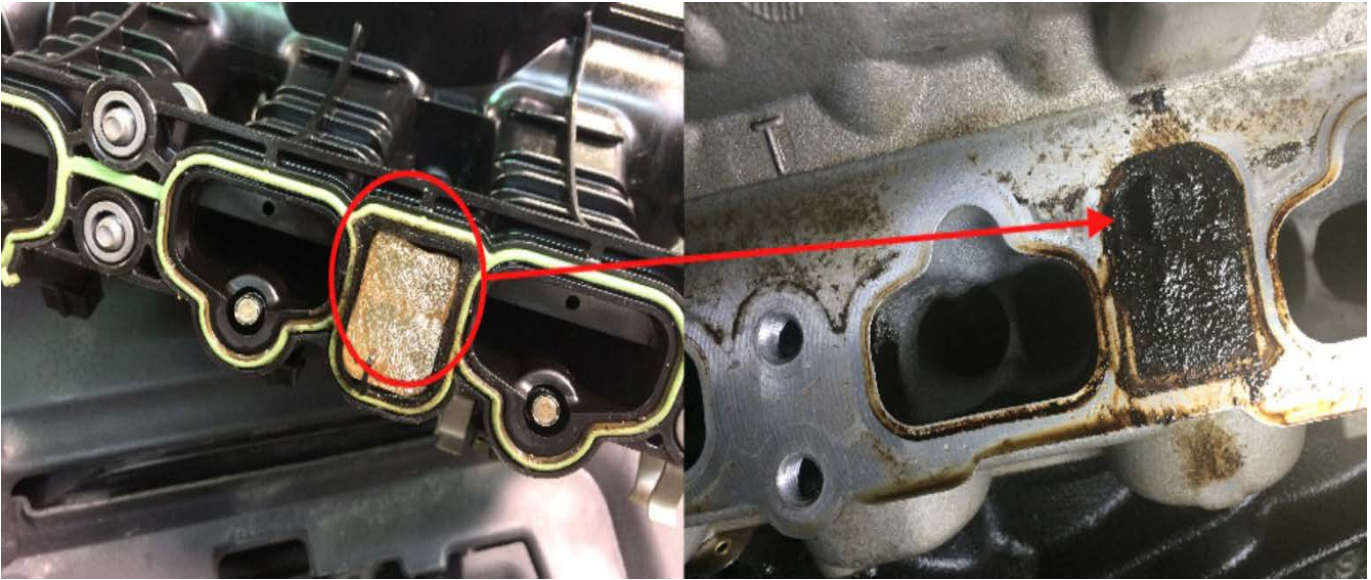
5286457

3. Inspect the PCV intake runner for ice build-up blocking the cylinder head as shown above.

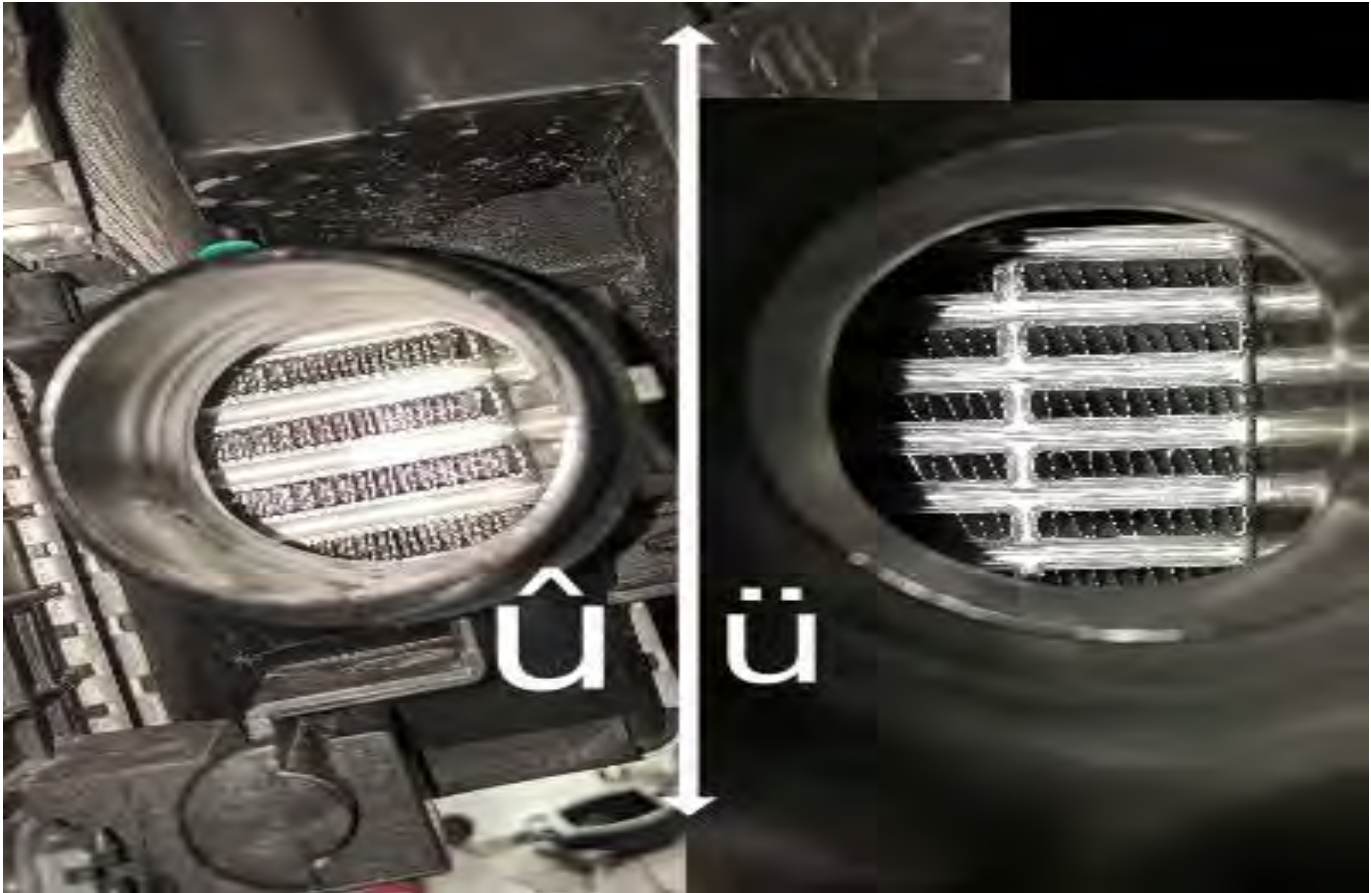
5500499

2. Inspect the charge air cooler through the inlet to determine if the vehicle has the new or old design.
 - If the charge air cooler is the old design (shown by X in the graphic), proceed to the Charge Air Cooler Replacement section below.
 - If the charge air cooler is the new design (shown by the check mark in the graphic – note the wider fin spacing and a division in the middle of the charge air cooler), no charge air cooler replacement is necessary.

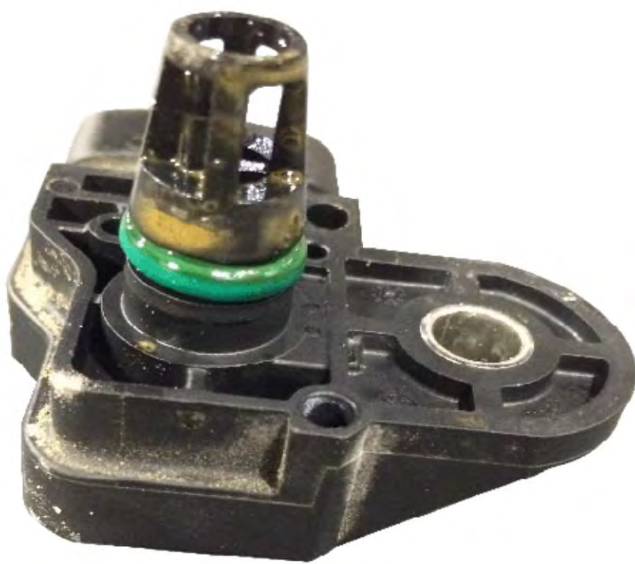
4910683

2. Inspect the IAPT sensor for any contaminates.

3. Allow time for any ice build-up to melt by placing the sensor port down.
4. Clean the sensor with a clean towel.
5. Inspect the IAPT sensor for any contaminates.
6. Install the sensor into the elbow duct.
