Service Bulletin

Bulletin No.: 17-NA-198

Subject: Difficulty Adjusting Manual Seat Height and/or Seat Stuck in Lowest/Highest Position

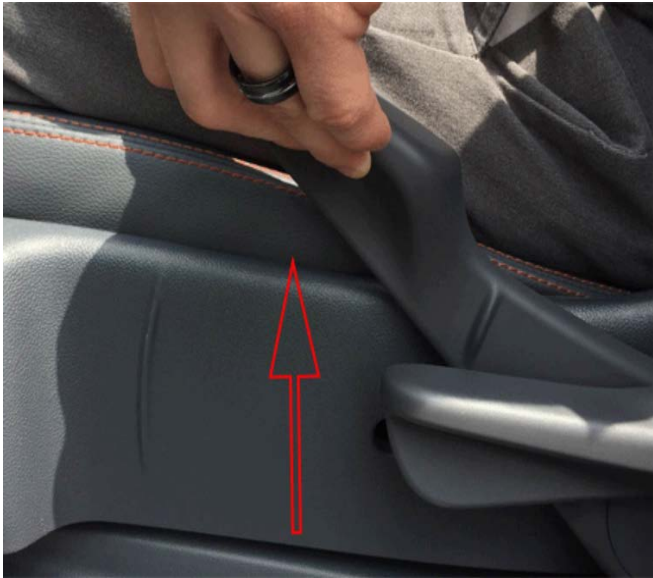
4820844

Involved Region or Country	North America, Europe, Middle East, China, GM Korea, Brazil, Chile, Colombia, Peru, Israel, South Africa, Australia, New Zealand
Condition	Some customers may comment that it is difficult to manually adjust the seat height and/or seat stuck in lowest/highest position.
Cause	This condition may be caused by the mechanical function of the height adjustment being jammed, not broken.
Correction	Disengage the jammed parts and release the gears for proper function.

1. Pull the lever with high force to disengage the jammed parts in the seat gear and release the mechanical function. If unsuccessful, continue to Step 2.
