Service Bulletin

Bulletin No.: 19-NA-004

Subject: Squeak or Creak Noise from Right Rear of Vehicle While Driving

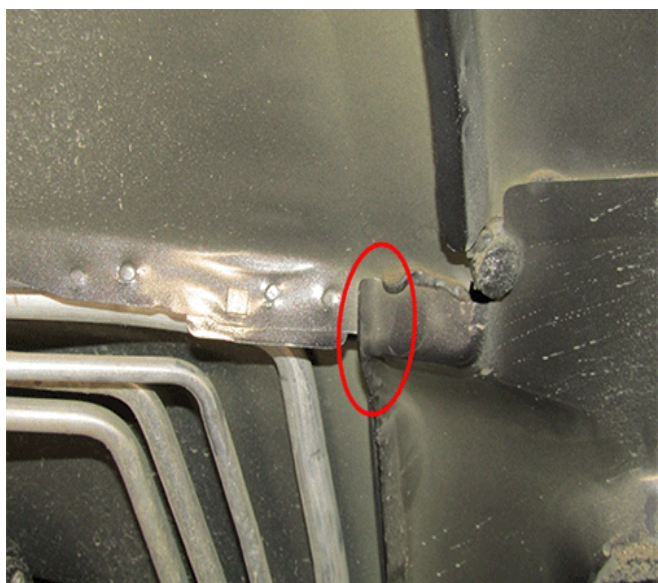
2. Locate the sheet metal seam/gap shown in the graphic above.
