# Service Bulletin

Bulletin No.: 19-NA-184

**Subject: Front Exterior Lighting Malfunction**

Brand:	Model:	Model Year:		VIN:		Engine:	Transmission:
		from	to	from	to		
Cadillac	XT4	2019	2019			All	All

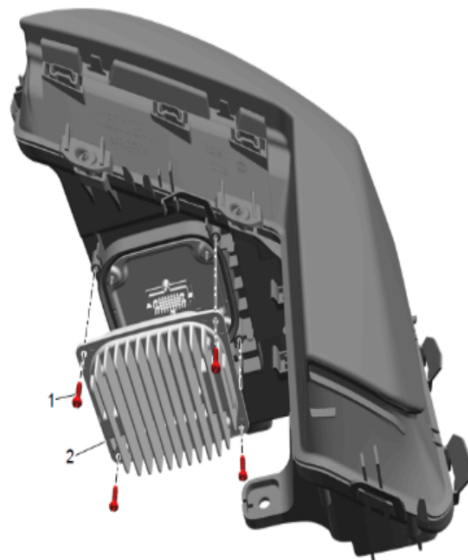
5393772

- Confirm that the low beam lamps are **always** on and cannot be switched off.
- Confirm that the DRL, high beams and parking lamps are ALL **inoperative**.
- Confirm that the turn signal lamps are **inoperative** and that the turn signal is operating as intended on the IPC. Even though the turn signal is not functioning, it will appear to the customer that it is functioning correctly.

**If all the prior criteria is met, replace the affected right and/or left headlamp automatic control module(s) (2).** Refer to *Headlamp Automatic Control Module Replacement* in SI.

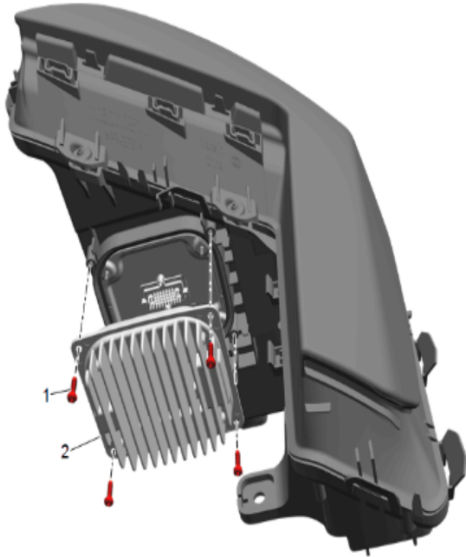
5393772

- Confirm that the low beam lamps are **always** on and cannot be switched off.
- Confirm that the DRL, high beams and parking lamps are **ALL inoperative**.
- Confirm that the turn signal lamps are **operative**.

If all the prior criteria is met, replace the affected right and/or left headlamp automatic control module(s) (2). Refer to *Headlamp Automatic Control Module Replacement* in SI.
