# Service Bulletin

Bulletin No.: 19-NA-243

**Subject: Power Door Locks, Keyless Entry, Power Windows and Power Mirror Inoperative, Power Seats, Power Telescope Steering Column Inoperative and/or Moving On it's Own, Side Object Detection Inoperative and/or Unwanted Activation, Multiple DTCs Set**

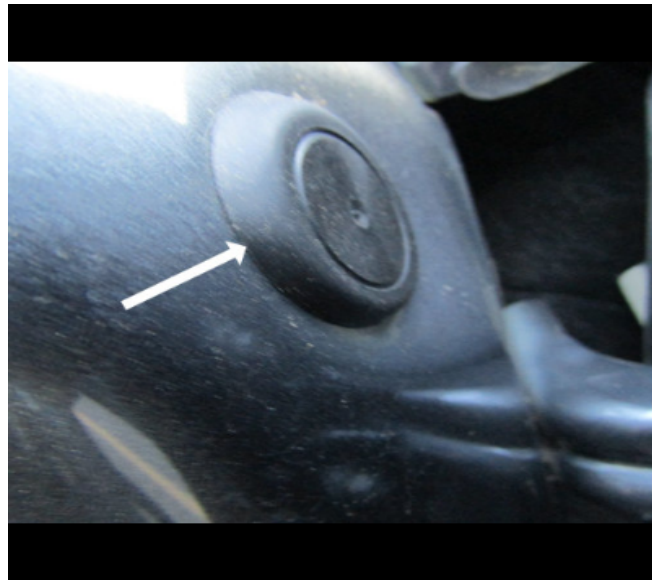
5429978

<b>Involved Region or Country</b>	United States, Canada, Mexico, Europe, Uzbekistan, Russia, Middle East, Israel, Palestine, Argentina (Mercosur), Brazil (Mercosur), Chile (West), Colombia (West), Ecuador (West), Paraguay (West), Peru (West), Uruguay (West), Japan, South Korea, Australia/New Zealand, Egypt, Africa
<b>Condition</b>	<p>Some customers may comment on one or more of the following conditions:</p> <ul style="list-style-type: none"> <li>• Power door locks inoperative</li> <li>• Keyless entry inoperative</li> <li>• Power windows and power mirror inoperative</li> <li>• Power seats inoperative and/or moving on it's own</li> <li>• Power telescope steering column inoperative and/or moving on it's own</li> <li>• Side object detection inoperative and/or unwanted activation</li> </ul> <p>Technicians may find multiple DTC's set.</p>
<b>Cause</b>	This condition may be caused by water leaking through the body plug above the connectors X500 & X600 causing the connector to be corroded.

Replace the body plugs with the revised part and repair the wiring as necessary. For repairing the wiring refer to *Wire to Wire Repair in SI*.

**Note:** The Equinox/Terrain only require 2 plugs (one plug for each side above X500 and X600) while all other vehicles require 4 plugs (two plugs for each side above X500 and X600).
