Service Bulletin

Bulletin No.: 20-NA-037

Subject: Unable to Start/Shut Off Vehicle, Extended Engine Crank Prior to Start, Battery Drain, Tail Lamps Inoperative, Unintended Brake Pedal Movement During Operation, and/or Traction Control/Stability System/ABS Indicators Illuminated

Brand:	Model:	Model Year:		VIN:		Engine:	Transmission:
		from	to	from	to		
Cadillac	Escalade	2017	2019			All	All

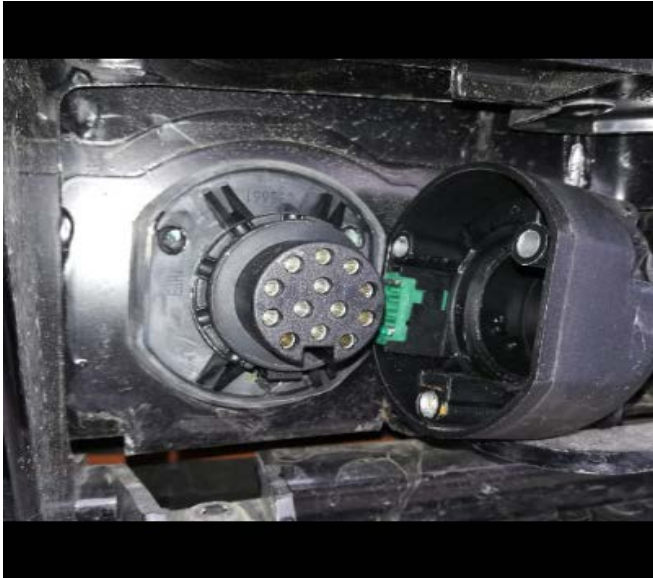
5521934

1. Inspect the trailer hitch wiring 13 pin receiver.

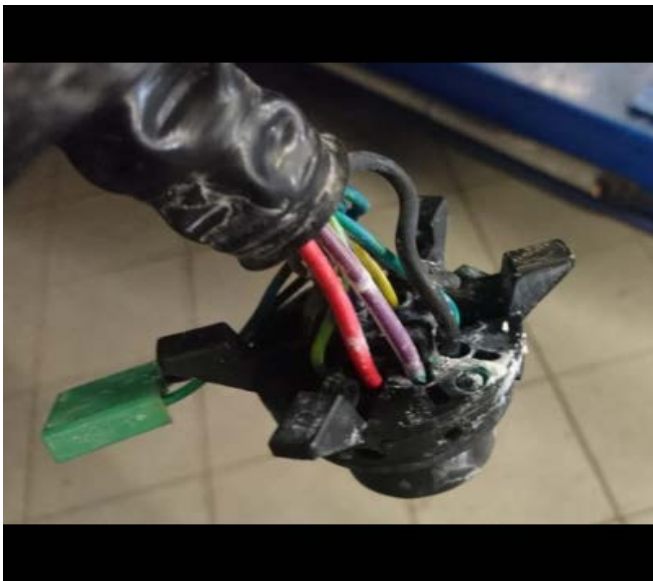
5521936

2. Remove electrical connector from receiver.

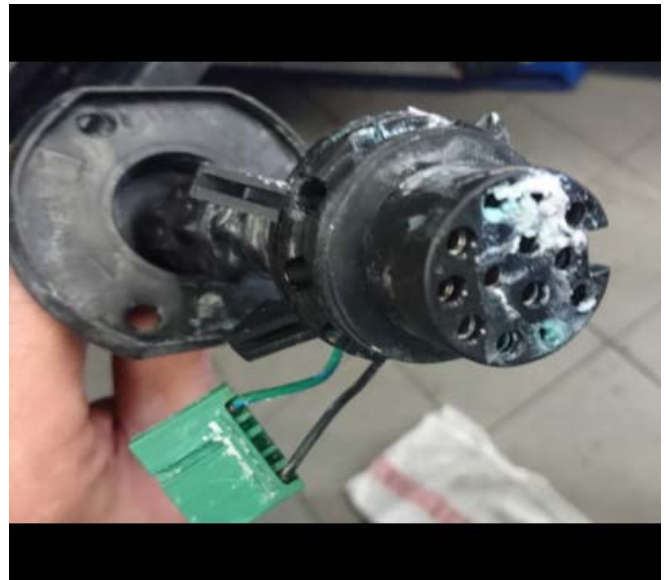
5521938

3. Visually inspect for corrosion at electrical insert.

6. Depending on the location and severity of water intrusion, clean the harness insert connector, or replace, and repair wiring as required. Verify functionality of the trailer wiring.

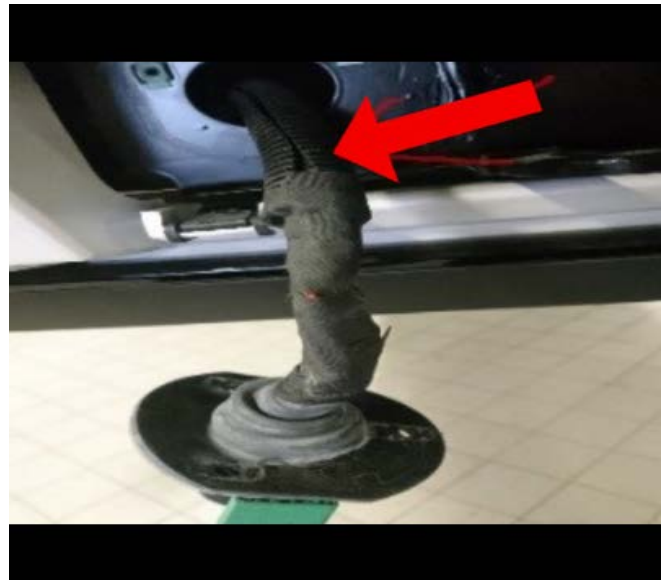
5521939

4. Visually inspect for water intrusion in harness.

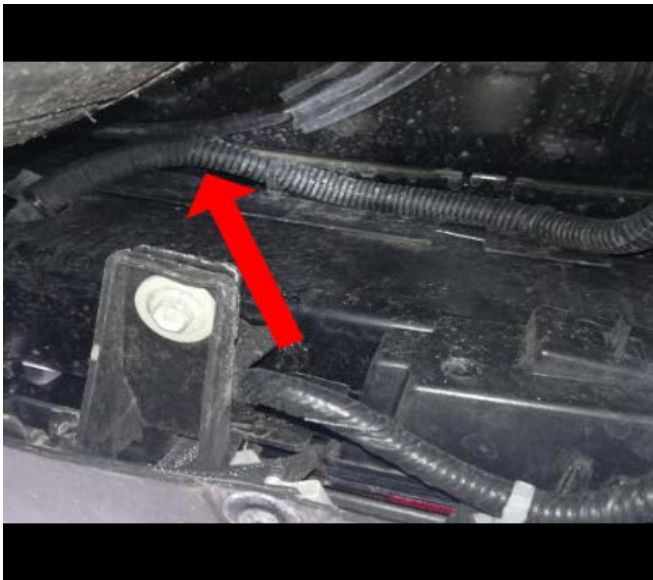
5521940

5. Visually inspect back protective shielding.

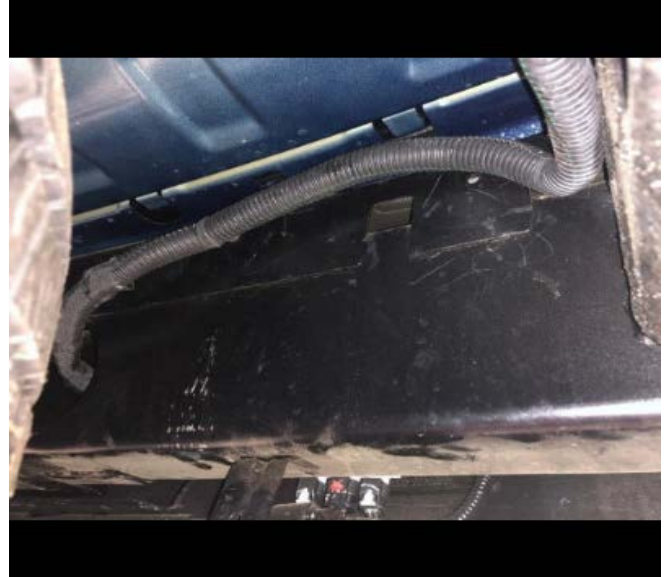
5535838

Before

8. For better protection of the trailer wiring harness, relocate tail of harness down to lower bracket of the rear impact bar like illustrated above in the before and after.
