Service Bulletin

Bulletin No.: 20-NA-040

Subject: Pickup Box Power Endgate May Not Open on Initial Press, or May Not Open at All

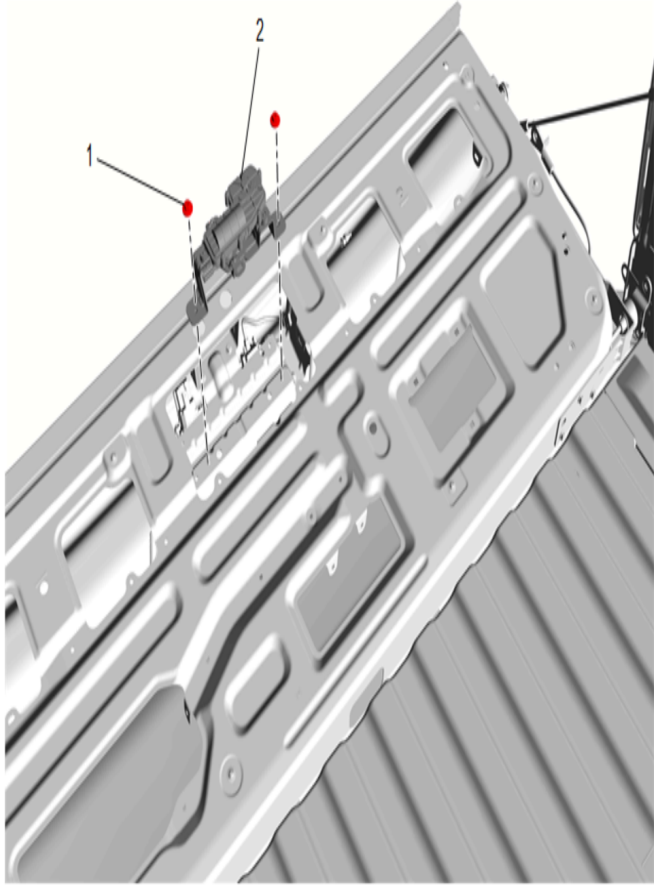
Involved Region or Country	North America, Europe, Russia, Middle East, Israel, Palestine, South America, Philippines, Australia, New Zealand, Egypt, Africa, South Africa
Additional Options (RPOs)	Equipped with QK1 and QT5
Condition	Some customers may comment on the power endgate may not unlatch or drop on first try, or under some conditions, it may not open at all.
Cause	The cause of the condition may be a combination of excessive spring force and low available voltage, which may cause the latch actuator to fail to function.
Preliminary Procedure	<p>Some vehicles, which have a tonneau cover installed, may be affected by a similar Condition, however the Cause and Correction are completely different from this bulletin. On these vehicles, it will be necessary rule out the tonneau cover as the possible Cause of the condition:</p> <ol style="list-style-type: none"> 1. Open the rear end panel of the tonneau cover. 2. Cycle the power tailgate 5 times using push button activation for auto open and close manually. <ul style="list-style-type: none"> • If the power endgate Does function properly, DO NOT proceed with this bulletin repair, but move on to Bulletin # 20-NA-044 and complete the tonneau adjustment procedure. • If the power endgate still DOES NOT function properly, continue on and complete the Correction outlined in this bulletin.

<p style="text-align: right; font-size: small;">5049815</p> <p>Upon verifying the condition, replace the pickup box endgate lock actuator (2) with an improved design service part. Refer to <i>Pickup Box Endgate Lock Actuator Replacement (Power)</i> in SI.</p>
--------------------------	---
