Service Bulletin

Bulletin No.: 20-NA-046

Subject: Malfunction Indicator Lamp (MIL) Illuminated - DTC P0365 and/or P0366 Set

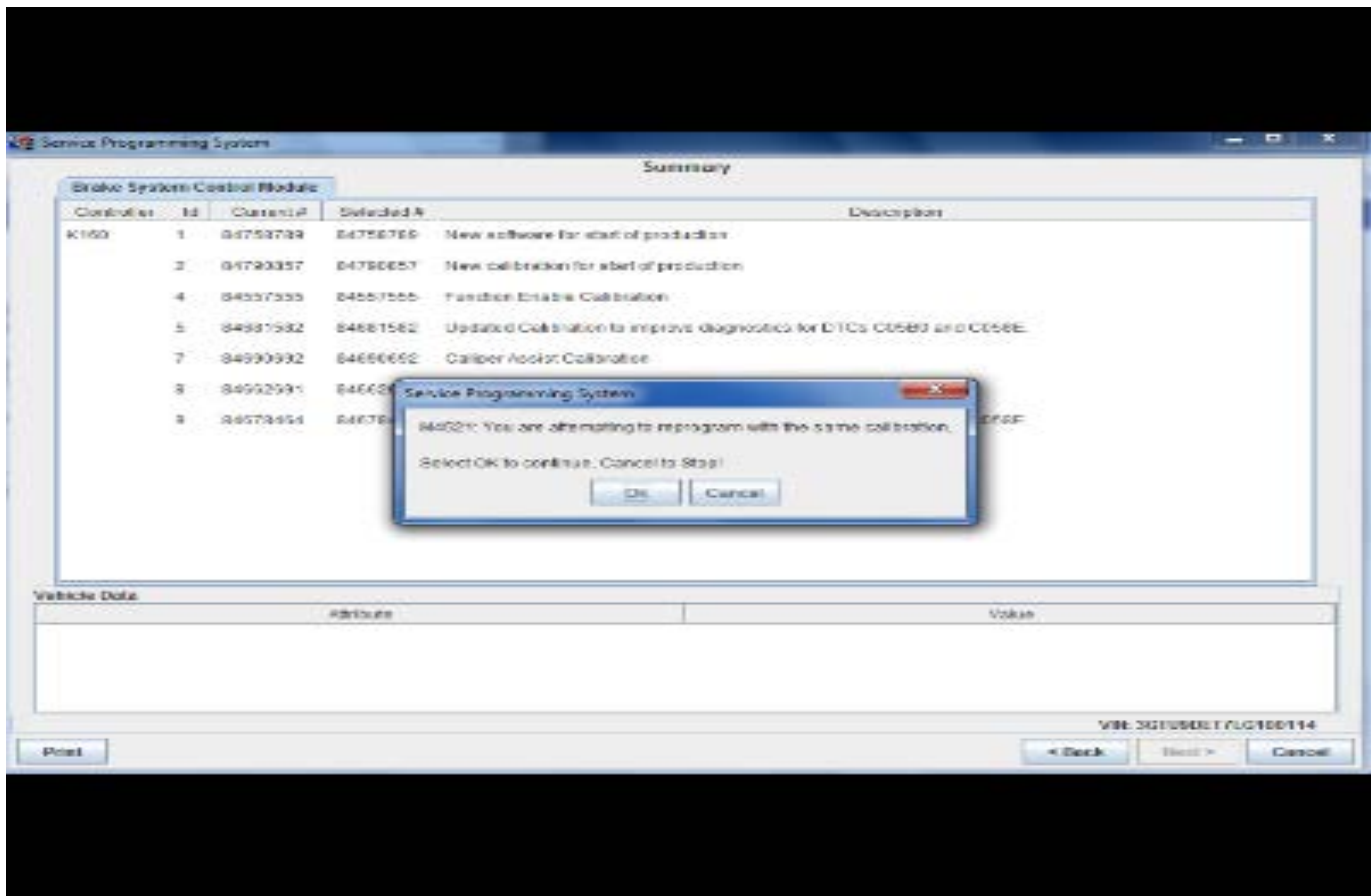
5431207

Important: If the Same Calibration/Software Warning is noted on the SPS screen, select OK and follow screen instructions. After a successful programming event, the WCC is located in the Service Programming System dialogue box of the SPS Summary screen. No further action is required. Refer to the Warranty Information section of this bulletin.
