# Service Bulletin

Bulletin No.: 20-NA-068

**Subject:** Service Engine Soon Message on Driver Information Center (DIC) with the following DTCs set: P00FF, B2B05, B2B06

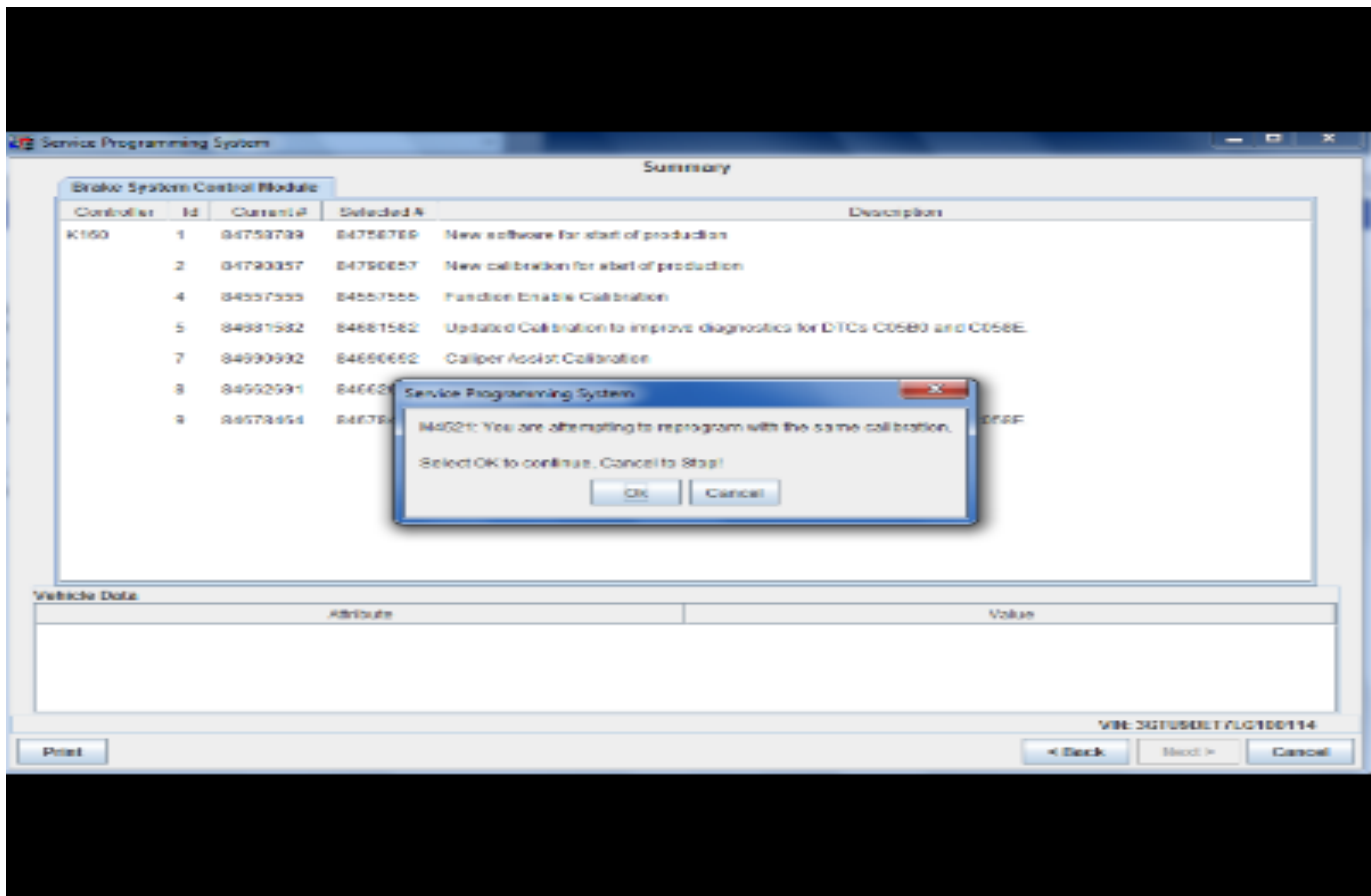
5431207

**Important:** If the Same Calibration/Software Warning is noted on the SPS screen, select OK and follow screen instructions. After a successful programming event, the WCC is located in the Service Programming

System dialogue box of the SPS Summary screen. No further action is required. Refer to the Warranty Information section of this bulletin.

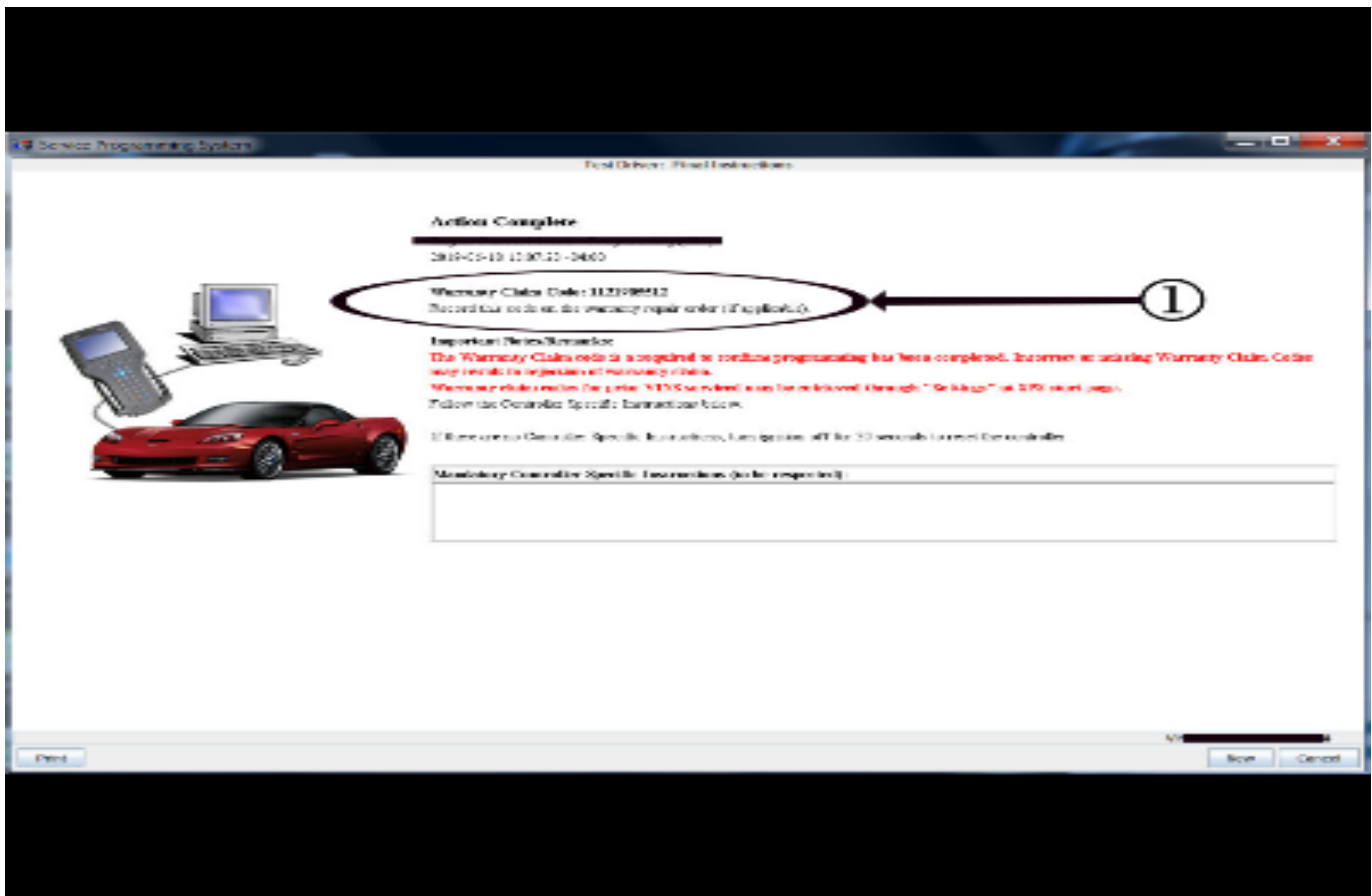
5431209

**Important:** To avoid warranty transaction rejections, you **MUST** record the warranty claim code provided on the SPS Warranty Claim Code (WCC) screen on the job card. Refer to callout 1 above for the location of the WCC on the SPS screen.

2. Record the SPS Warranty Claim Code on the job card for warranty transaction submission.
