Service Bulletin

Bulletin No.: 20-NA-070

Subject: Instrument Cluster Driver Information Center Defaults to Settings or Units Page at Start

Brand:	Model:	Model Year:		VIN:		Engine:	Transmission:
		from	to	from	to		
Buick	Enclave	2020	2020				
Chevrolet	Traverse	2020	2020				
GMC	Acadia	2020	2020

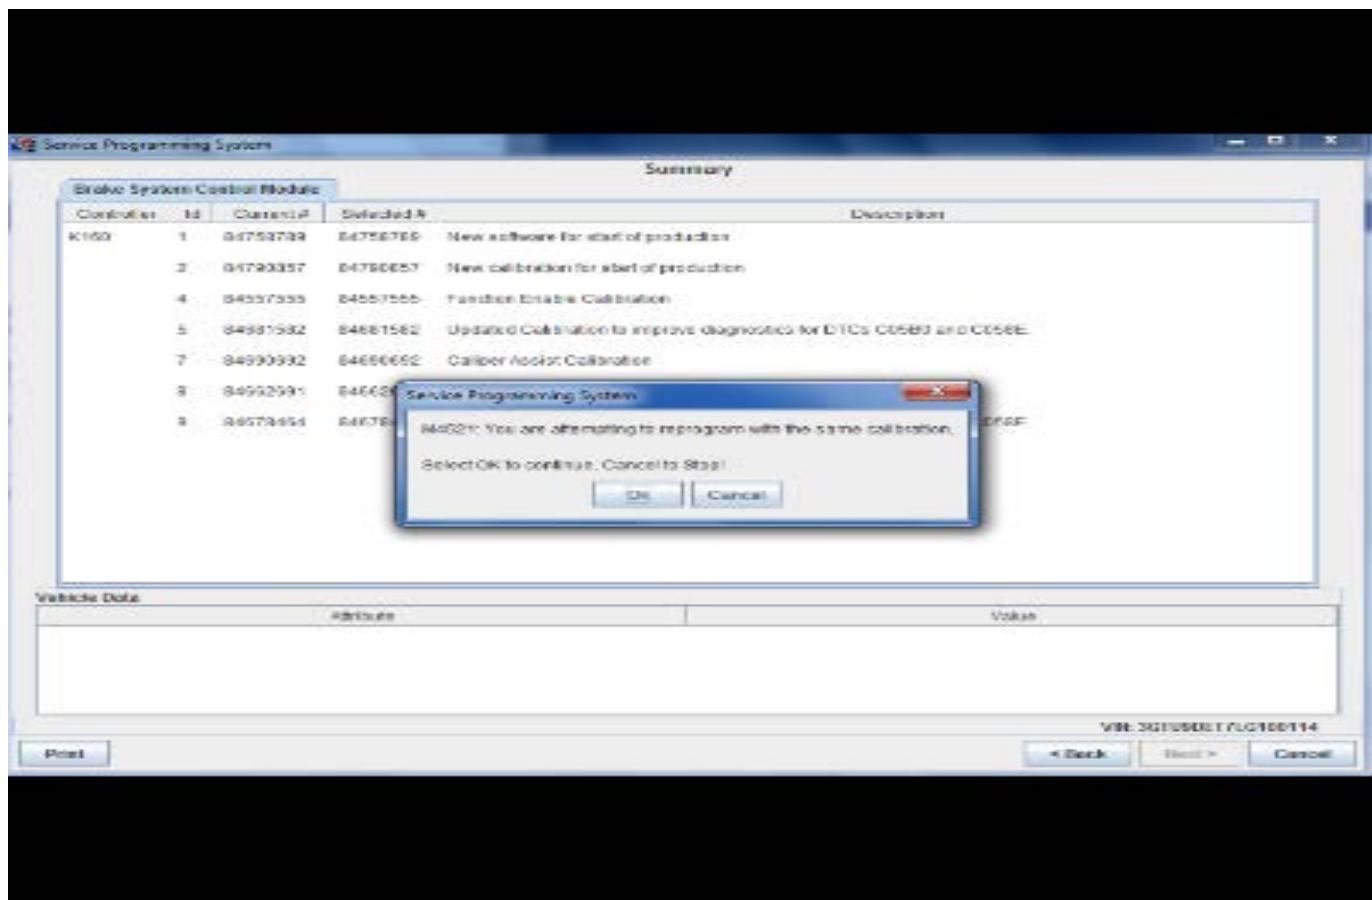
Important: If the Same Calibration/Software Warning is noted on the SPS screen, select OK and follow screen instructions. After a successful programming event, the WCC is located in the Service Programming

System dialogue box of the SPS Summary screen. No further action is required. Refer to the Warranty section of the bulletin.

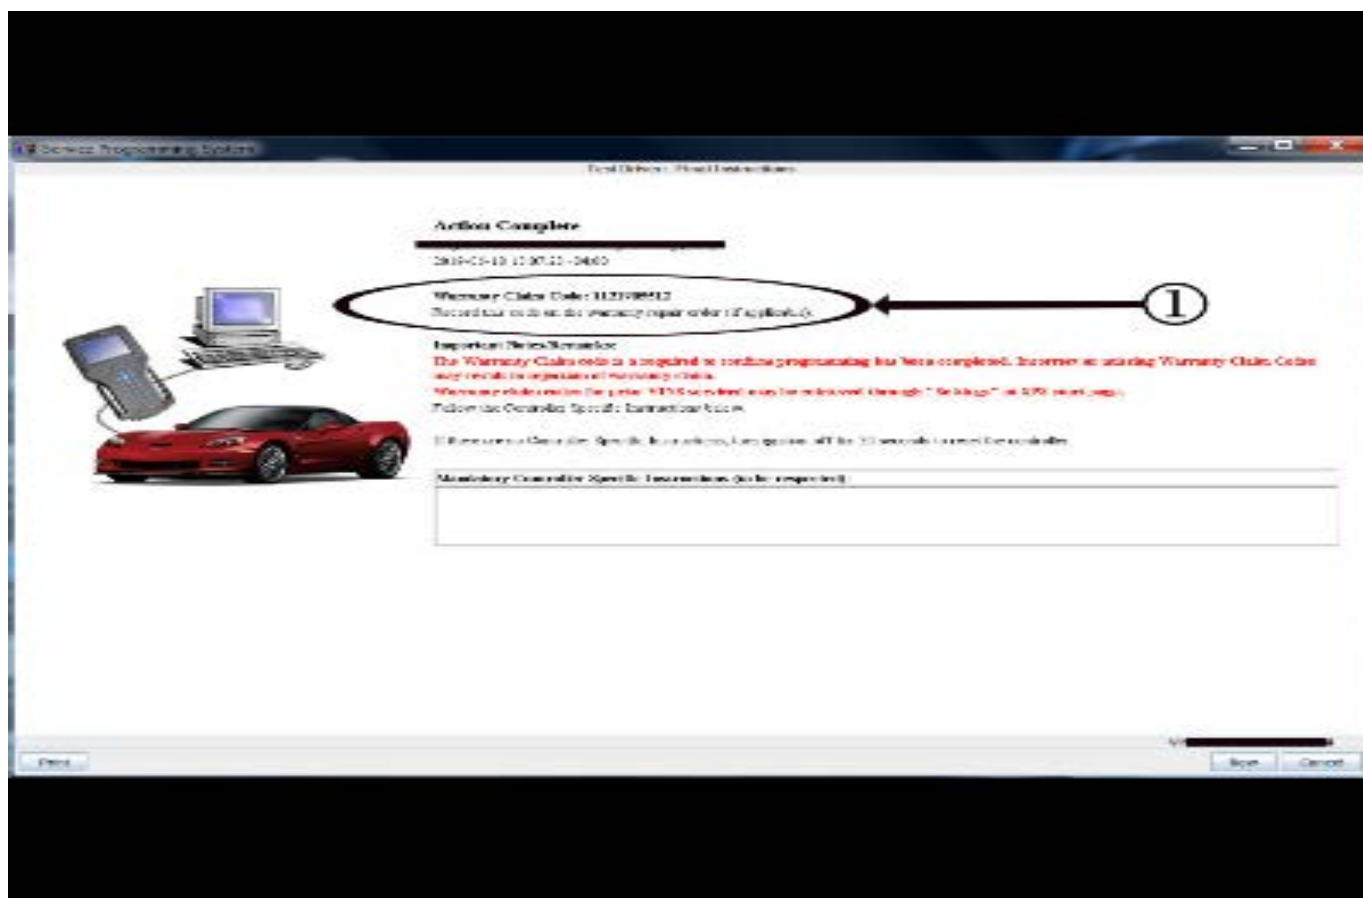
5431209

Important: To avoid warranty transaction rejections, you **MUST** record the warranty claim code provided on the SPS Warranty Claim Code (WCC) screen on the job card. Refer to callout 1 above for the location of the WCC on the SPS screen

2. Record SPS Warranty Claim Code on job card for warranty transaction submission.
