Service Bulletin

Bulletin No.: 20-NA-071

Subject: Service Engine Soon Lamp Illuminated and/or Service Power Brake Assist Message Displayed, with DTCs P0557 or P0558 Stored

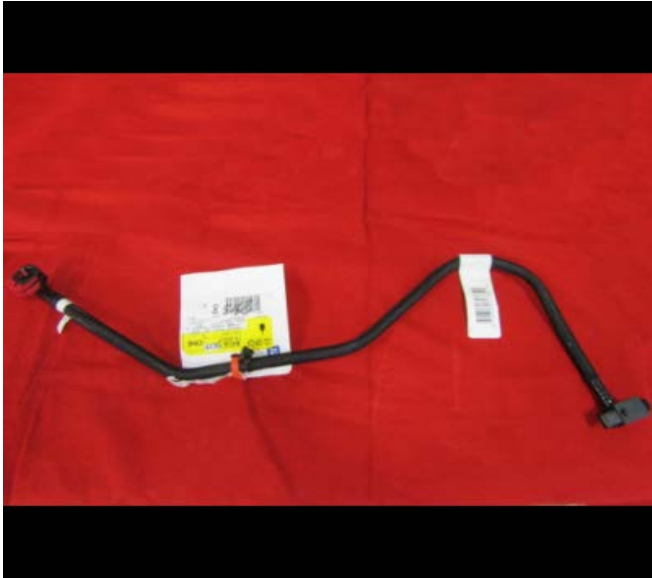
5549611

LGX Hose

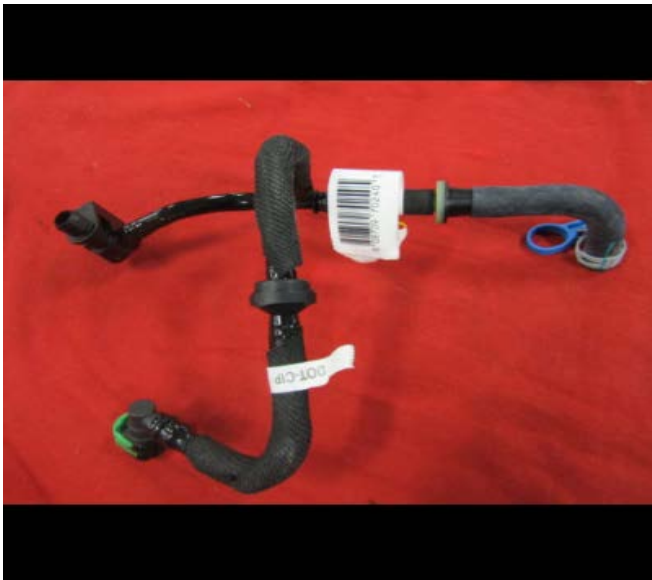
5549612

LFY Hose

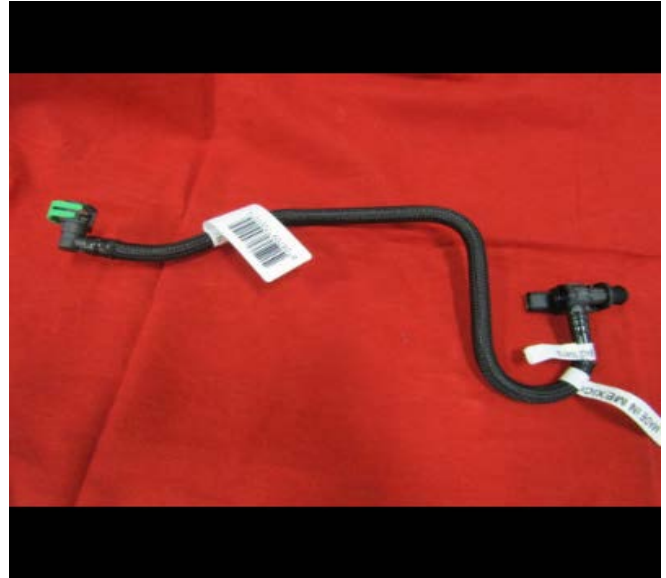
5549615

LCV Hose

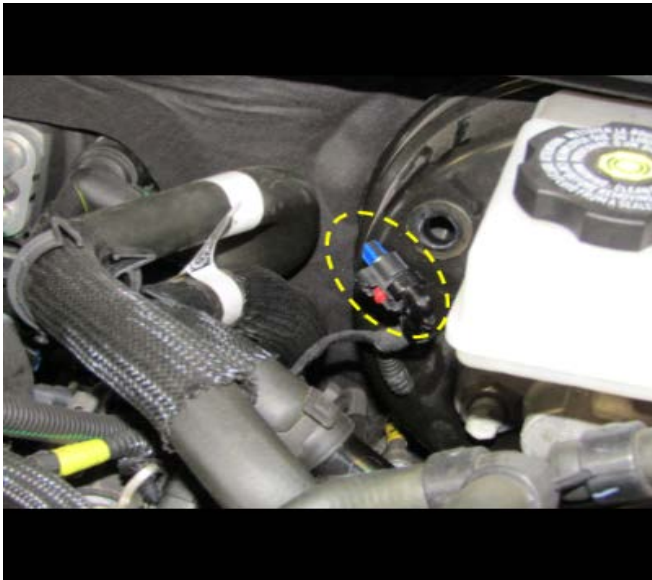
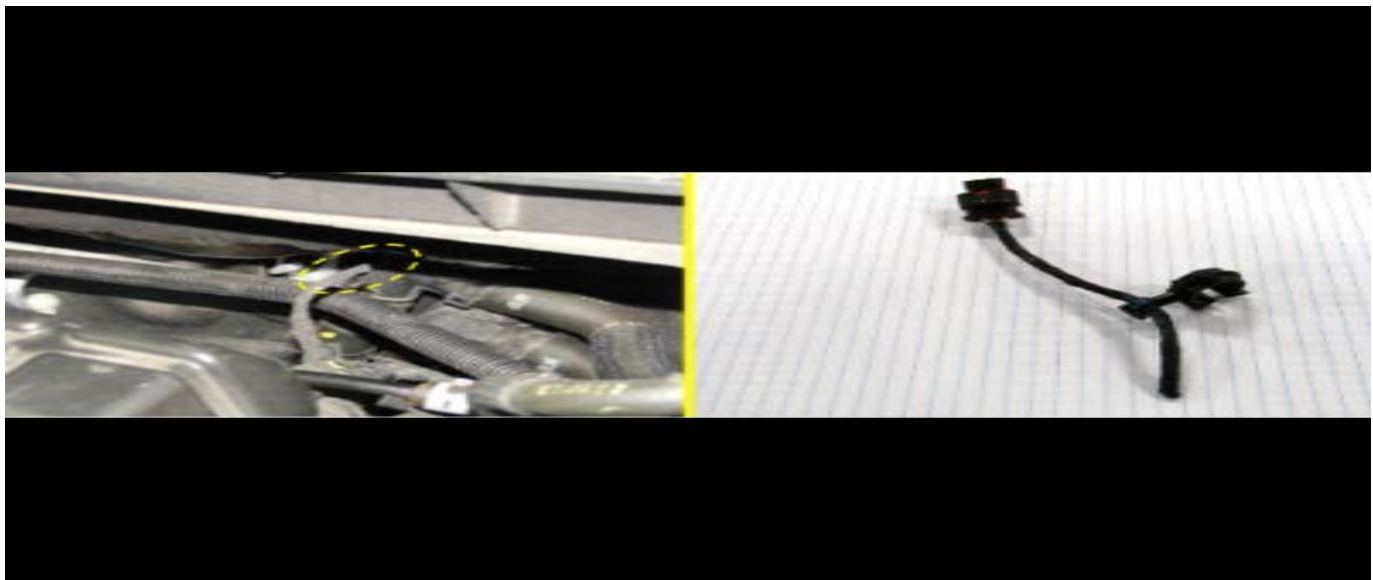
Note: The top graphic shows the LGX connector intact; the bottom one shows the LFY wiring already cut.

2. Locate the power brake booster vacuum sensor electrical connector. Fold conduit back and cut off connector, leaving approximately 5.0 cm (2.0 in) of wiring on the engine harness side.

3. Tape the cut wiring end to the engine harness. These wires will no longer be used.

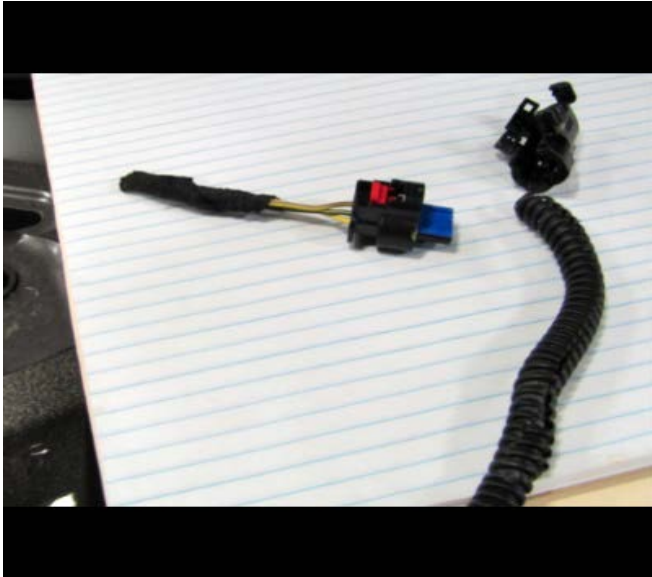
5549619

Note: Not all applications will have a cover on the connector.

4. Remove conduit and cover from the old connector.

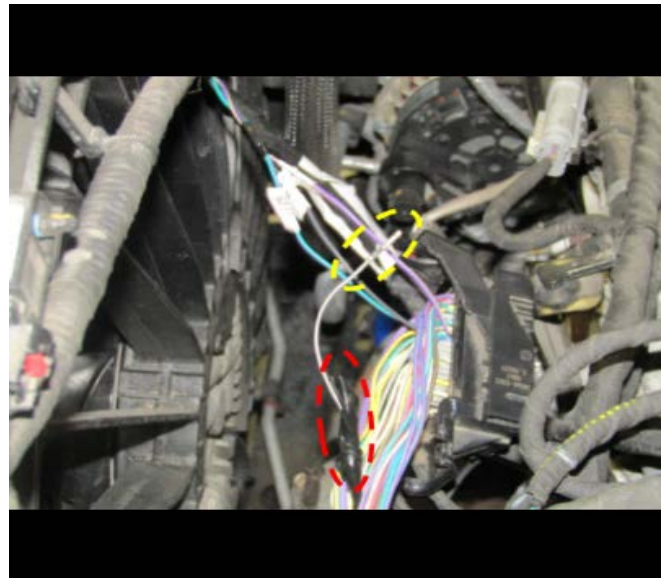
5549629

Note: In this step, do NOT cut the terminal off of circuit #6032 (circled in yellow in the graphic above).

15. Cut off the terminated leads that were in circuits #6030 and #6031 and fold and tape off the ends (circled in red in the graphic above). These circuits will no longer be used.

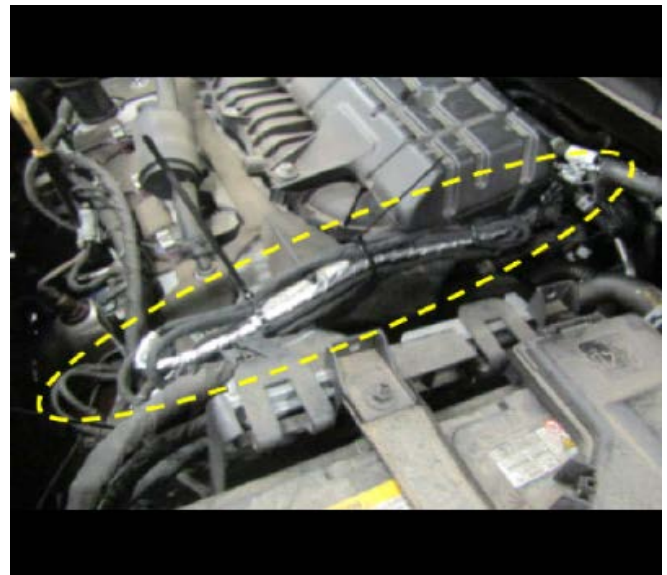
5549633

Note: Graphic shown above is LFY harness routing.

Important: It will be necessary to coil the extra wire length. Ensure the wire is tied back away from any sharp edges or moving parts that could cause damage to the harness.

28. Secure the new harness to the engine wiring harness using at least 5 or 6 tie straps.
29. Check and clear any DTC's, as necessary.

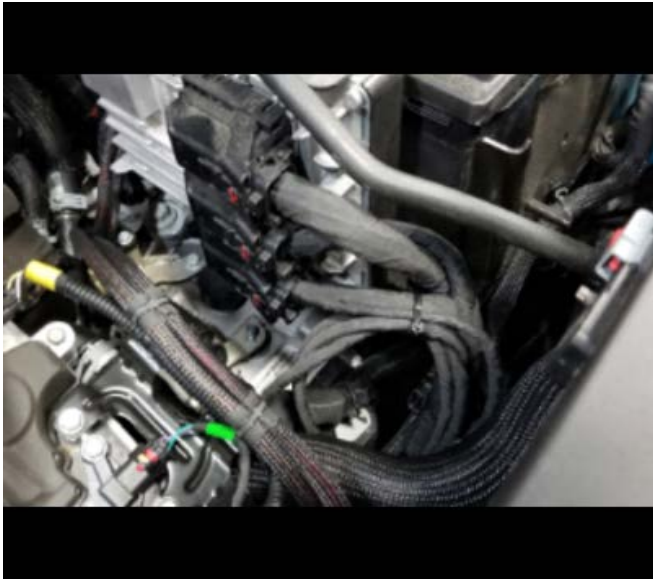
5549634

Note: Graphic shown above is LGX harness routing, with LCV being similar.
