Service Bulletin

Bulletin No.: 20-NA-072

Subject: Instrument Cluster Distance to Empty May Be Missing a Digit

Brand:	Model:	Model Year:		VIN:		Engine:	Transmission:
		from	to	from	to		
Cadillac	XT4 XT5 XT6	2020	2020

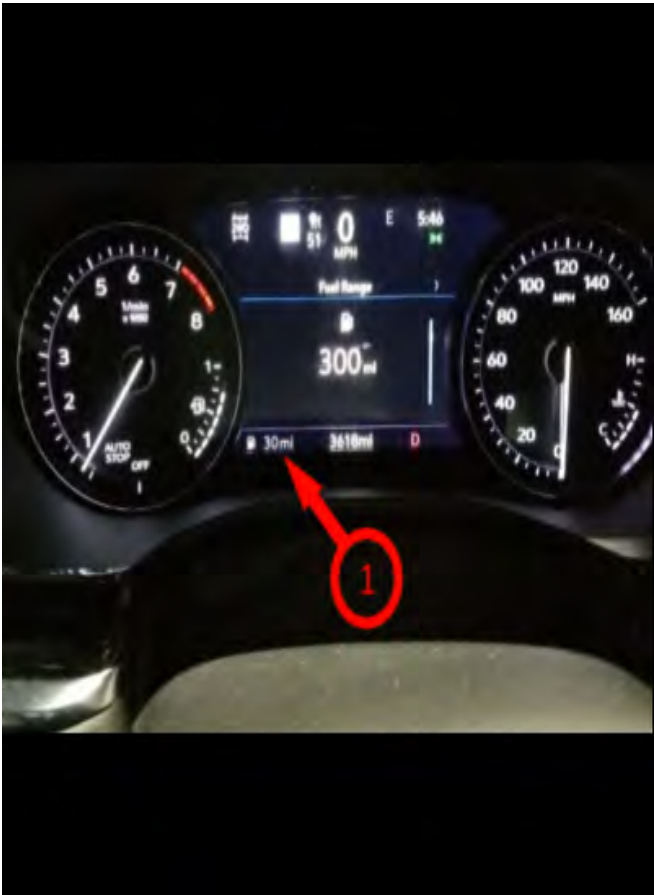
5550621

Involved Region or Country	United States, Canada, Mexico, Europe, Russia, Middle East, Israel, Palestine, Japan, Cadillac Korea (South Korea)
Additional Options (RPOs)	Equipped with Instrument Cluster (UHS)
Condition	<p>Some customers may comment that when the Distance to Empty (DTE) is in the approximate range of 300 miles to empty the driver information center (DIC) distance to empty value loses a digit.</p> <p>Note: Example: at 300 miles / 482 Kilometers to empty it may show DTE value as 30 miles / 48 Kilometers in the lower left corner of the DIC. The display will correct itself, but the condition can return the next time DTE is near that 300 mile range.</p>

Cause	The cause of the condition may be a software anomaly.
Correction	Reprogram the instrument cluster via USB
