Service Bulletin

Bulletin No.: 15-06-01-002I

Subject: Engine Misfire/Tick Noise, Malfunction Indicator Lamp (MIL) Illuminated - DTC P0300 Set

Models: 2015-2019 Cadillac Escalade
2016-2019 Cadillac CTS-V
2014 Chevrolet Silverado 1500
2014-2019 Chevrolet Corvette
2015-2018 Chevrolet Silverado
2015-2019 Chevrolet Suburban, Tahoe
2016-2019 Chevrolet Camaro
2019 Chevrolet Silverado LD
2014 GMC Sierra 1500
2015-2018 GMC Sierra
2015-2019 GMC Yukon, Yukon XL
2019 GMC Sierra Limited
Equipped with 5.3L Engine (RPOs L83, L8B) or 6.2L Engine (RPOs L86, LT1, LT4)

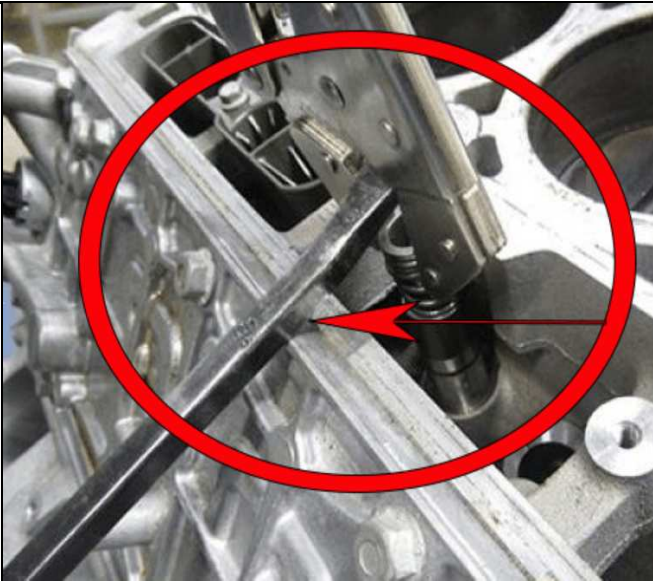
4921302

Note: Be sure **NOT** to pry on the sealing surface of the block, as shown in the illustration above.

2. Use vice grips with a small pry bar.
