SIB 66 03 20

2020-03-04

DIAGNOSTIC HINT: DRIVING ASSISTANCE SUPPORT REDUCED CHECK CONTROL MESSAGE DISP

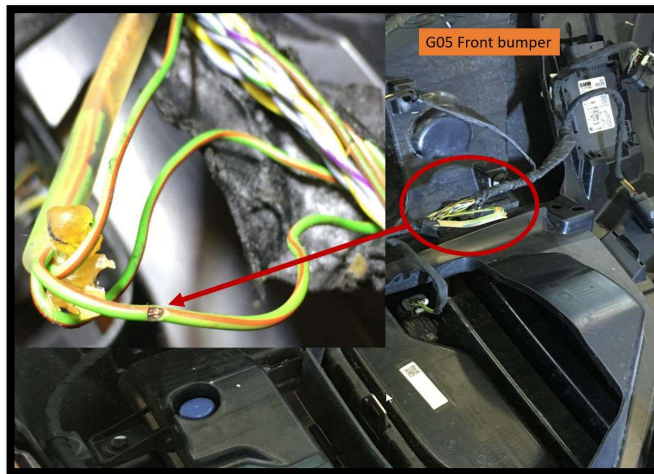
This image shows fault code S0261- No communication with KAFAS camera. The root cause was failure of the twisted pair wire (ethernet) between BDC and KAFAS.

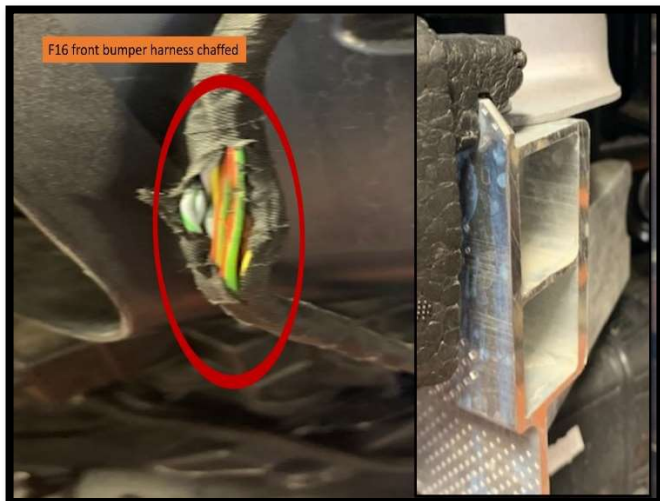
This image shows chaffed wire in the front bumper harness. The exposed wire makes contact with and sporadically shorting out against the front bumper support bracket. This may cause fuse 92 to fail.
