SIB 72 04 17

2020-03-18

FALSE WARNINGS THAT THE FRONT PASSENGER SEAT IS OCCUPIED WITHOUT THE SEAT BELT BUCKLED

PASSENGER OCCUPANCY DETECTION ERROR CORRECTION

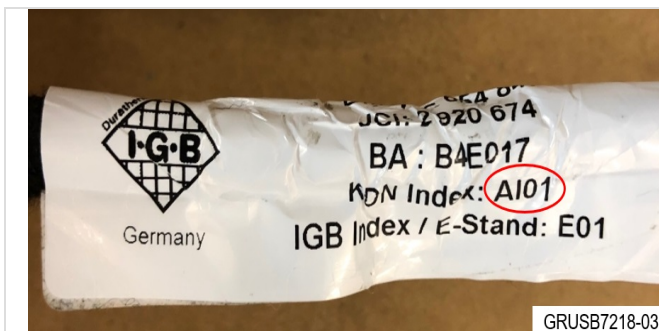
As referenced in the Diagnosis Chart attachment, an AI index of 01 is shown (circled).

4. Install 2 cable ties on the seat wiring harness as shown in the attached repair instructions and in this video <https://tinyurl.com/V520218>

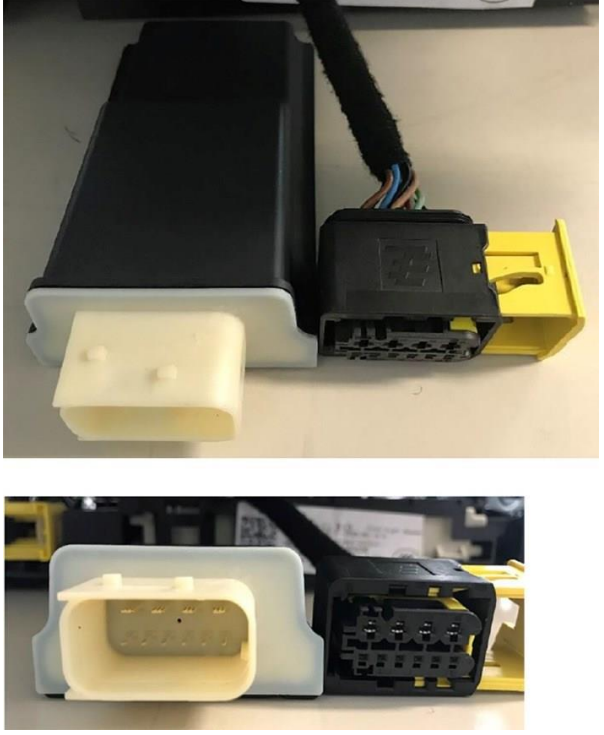
<ol style="list-style-type: none"> 4. Check the plug for conditions resulting in impossible poor electrical connection – corrosion, bent pins, etc. – removing control unit if needed, as shown. 5. Repair any connection problems. 6. Securely re-install control unit, if removed. 7. Reconnect plug into CIS.

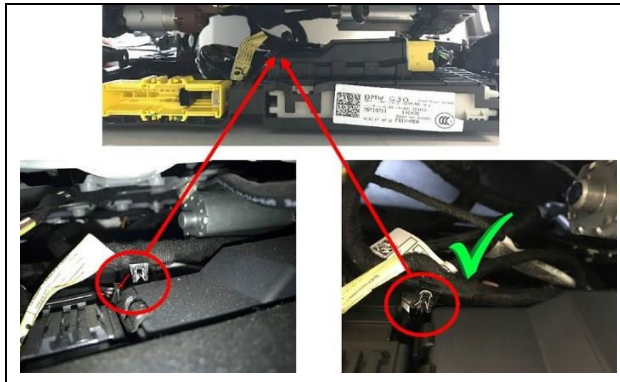
8. Secure the loose clip attached to cables, as shown.

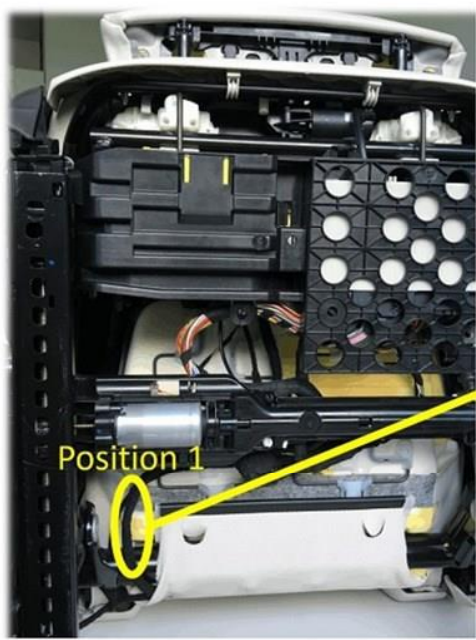
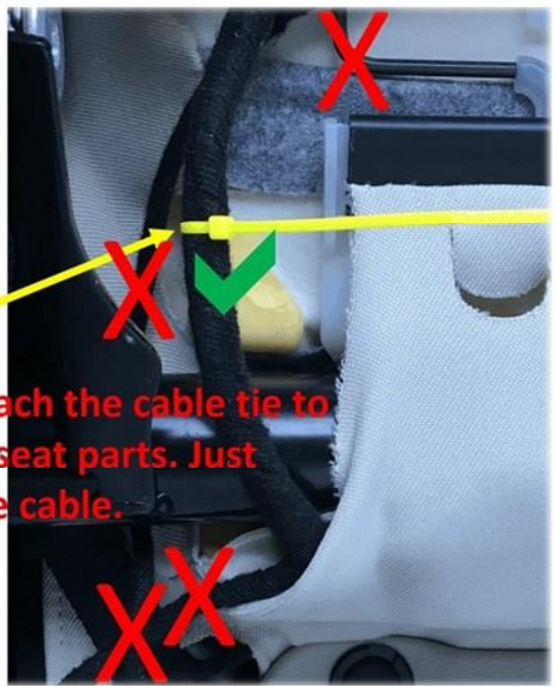
First cable tie position as shown in above photo

Do not attach the cable tie to any other seat parts. Just around the cable.

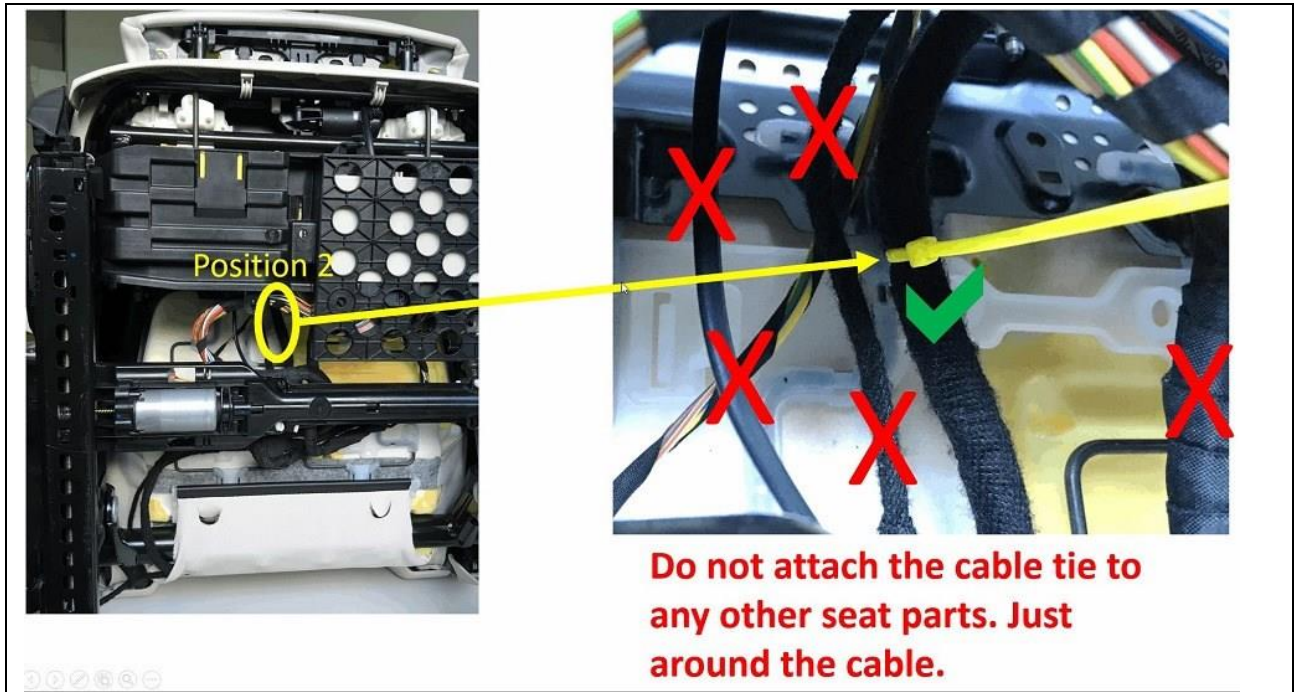
Secound cable tie position as shown in above photo

<p>UPDATE!</p> <p>9. With the tool shown in the picture, tie the cable tie only around the harness. To correctly tension the cable tie set the tool to 3.75</p>
--	---
