Engine runs irregularly and shakes. Check engine lamp lights up

Topic number	LI03.10-N-071148
Version	1
Function group	03.10 Connecting rods, pistons
Date	03-19-2020
Validity	Model 906 with engine OM651 Model 906, 907 with engine OM642
Reason for change	Contents revised Market validity adapted
Reason for block

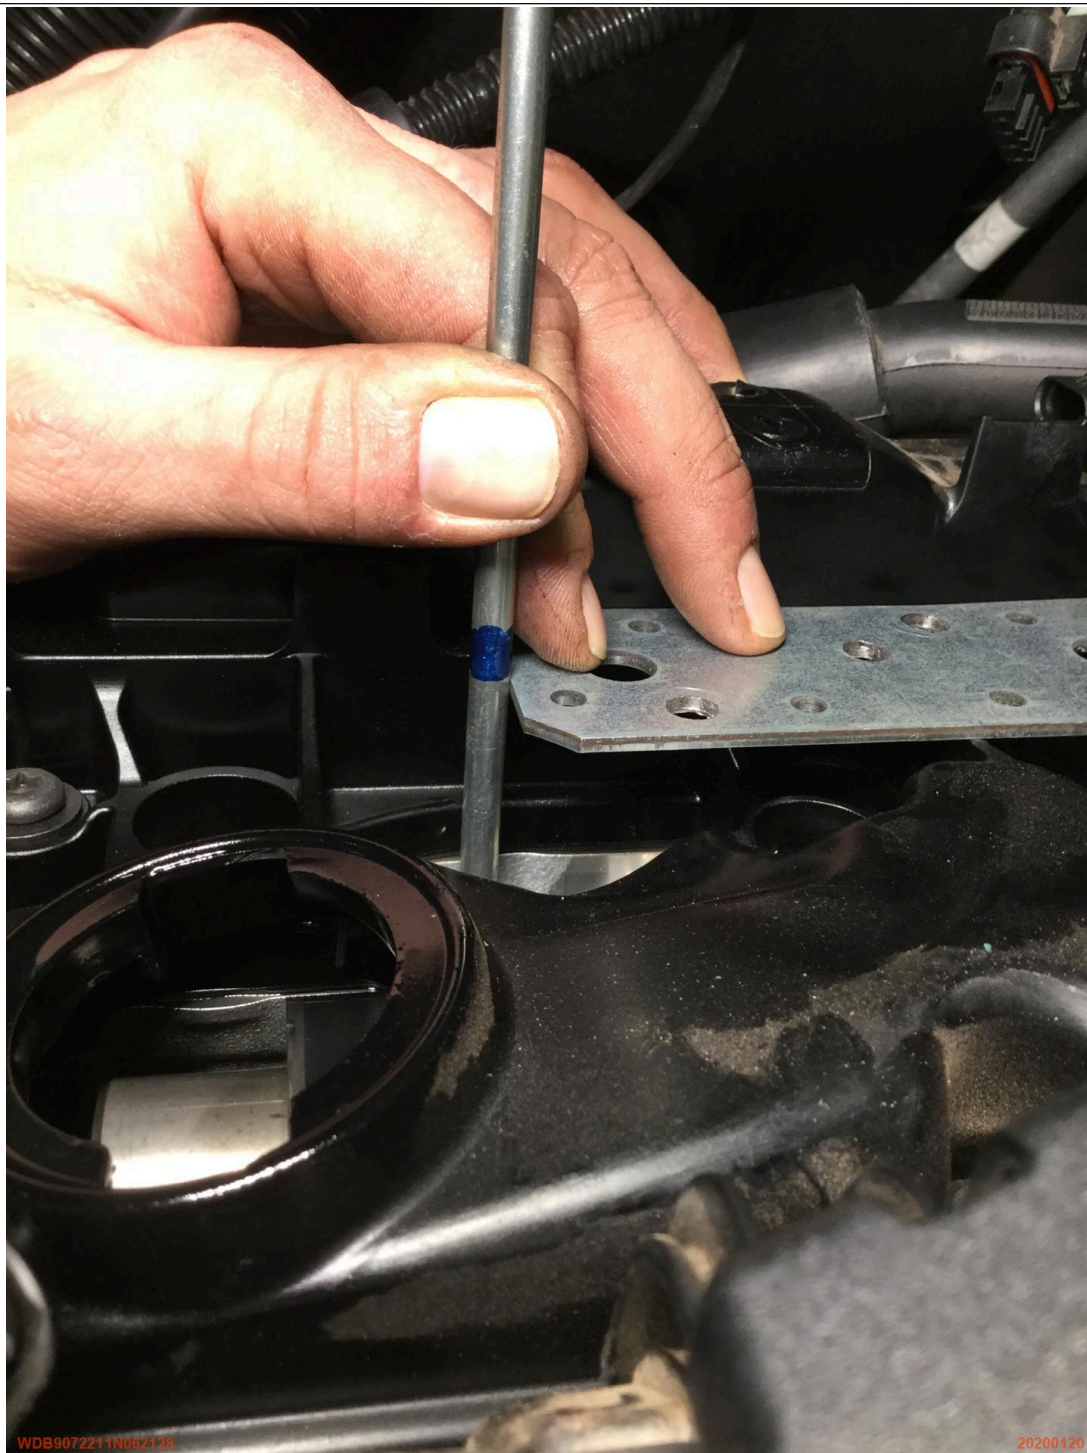
01.jpeg:

8. Manually turn cylinders, one after the other, to TDC position (see AR01.00-D-0100SF in model 906 with engine 642, AR01.00-D-0100-01TSV in model 907 with engine 642, AR01.10-D-1000-01WE in model 906 with engine 651) and use welding wire or a vernier caliper through the fuel injector slot to measure the distance to the piston (see Picture 01 and 02).

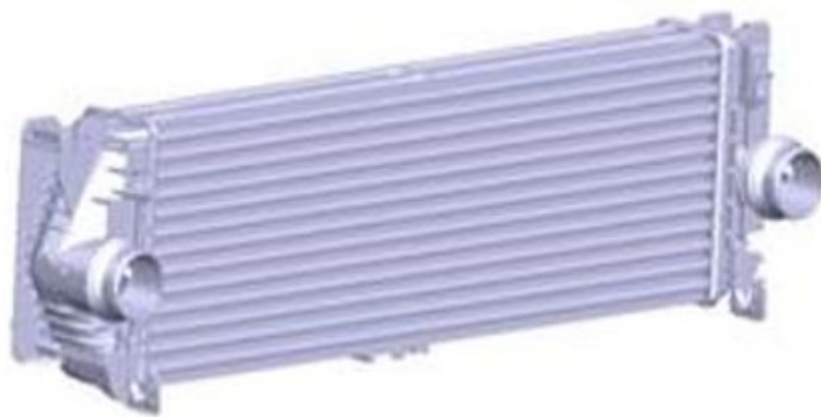
03.jpeg:

Information: For an older as-built configuration (fitting in center, see Picture 03, 04 and 05), continue with operation step 11.

11. Replace charge air cooler (see AR09.41-D-6817SD in model 906 with engine 642, AR09.41-D-6817TS in model 907 with engine 642 or AR09.41-D-6817WE in model 906 with engine 651).

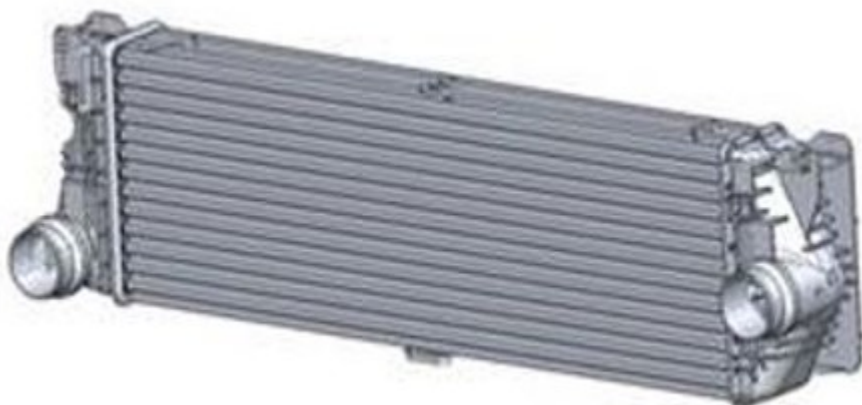
04.jpeg:

Information: For a current as-built configuration (see Picture 03, 04 and 05), do not undertake any more repair measures.

Information: The new charge air cooler with lowered fitting on the cold side (see AR09.41-D-8619M in model 906 with engine 642, AR09.41-D-8621TSR in model 907 with engine 642 or AR09.41-D-8619WE in model 906 with engine 651) must be installed (see Picture 04 and 05). Cost acceptance to be checked through advance agreement with regard to goodwill (ESKULAB). The modification of the charge air cooler is to be applied for as additional work through an ESKULAB query for engine damage (Note service information bulletin SI01.10-S-0001A hereto).
