Technical Service Bulletin

20 MIL on or difficulty refueling, DTC P045100, P044100, P202500, and/or P045300 are stored in the ECM

20 20 26 2050276/6 April 23, 2020. Supersedes Technical Service Bulletin Group 20 number 20-25 dated February 12, 2020 for reasons listed below.

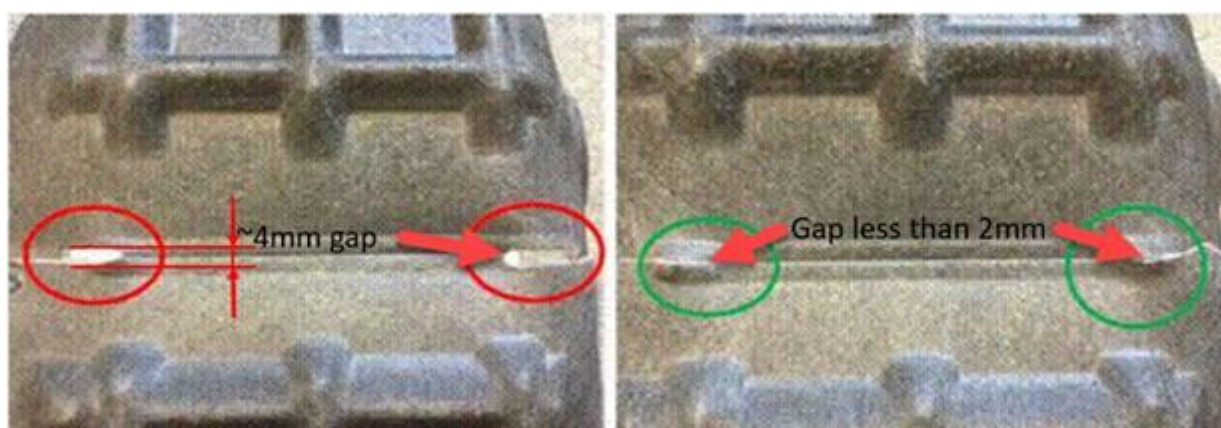
Figure 1. How to determine which steps to take Version 1 (~4mm gap) or Version 2 (gap less than 2mm).

Version 1 (A6 only):

1. If the updated wheel liner has not yet been installed. Then install the updated wheel liner, which has closed slots around the NVLD filter.
 - Remove the EVAP canister, ventilation tube, and NVLD pressure switch.
 - Remove all components mounted on the EVAP canister.
2. Weigh the EVAP canister:
 - If it weighs more than 2650 grams, replace the EVAP canister + attached filter, ventilation tube (Figure 2), and NVLD pressure switch (J909).
 - If it weighs less than 2650 grams, replace the ventilation tube, and the J909.

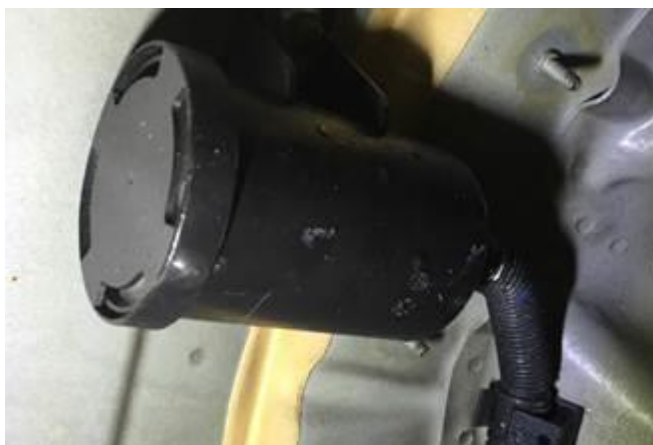
Figure 2. Ventilation tube of the EVAP canister.

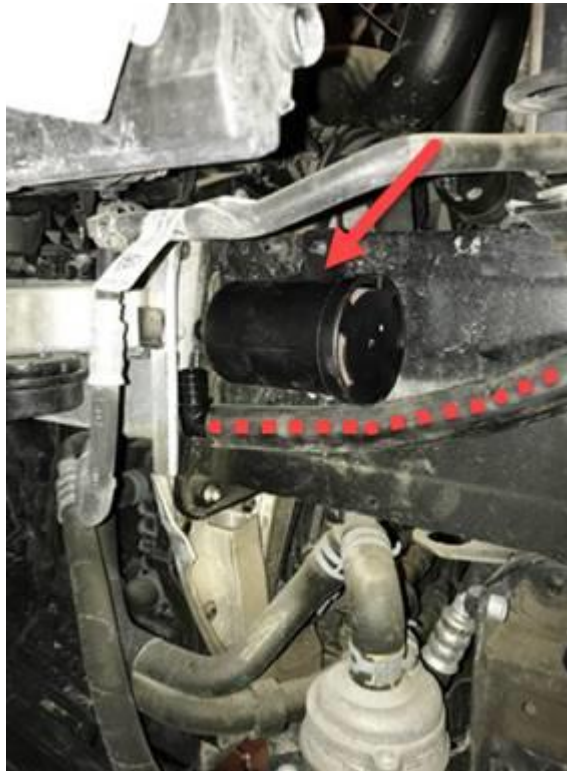
Figure 3. Installing the new NVLD filter.

1. Replace the EVAP canister only if weight is greater than 2650 grams.
 - Install a new J909.
 - Install the NVLD filter (new part number, Version 2) in the engine compartment on the left frame rail just in front of the ABS module, secure with M6 nut. (Figure 3).

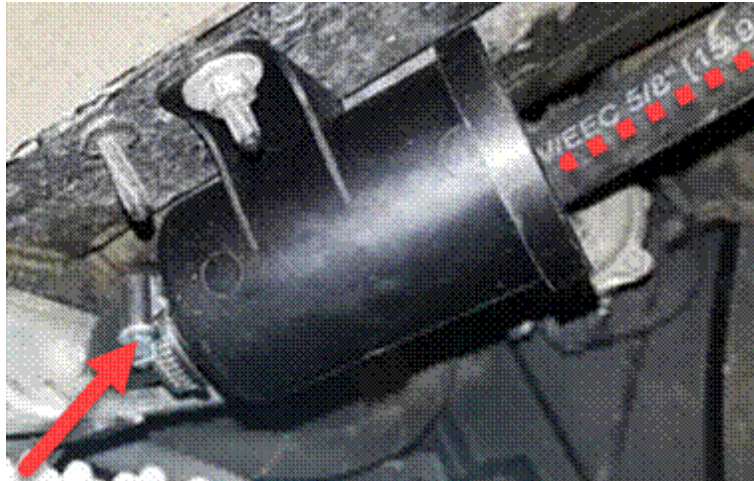
Figure 4. Connecting the NLVD filter.

2. Connect the filter to the 5/8" ID rubber hose via 1x plastic elbow and 1x rubber elbow (Figure 4).

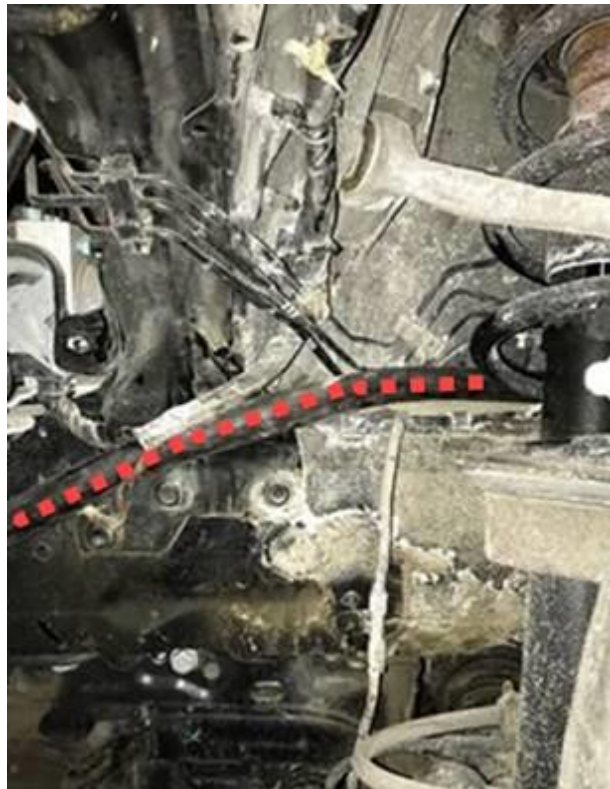
Figure 5. Route the 5/8" ID rubber hose from new filter position to the J909.

- Route the 5/8" ID rubber hose behind the strut and brake lines from new filter position to the J909, along the orange battery cable (Figure 5 and 6). Then secure with zip ties.
- 3.

5/8" ID rubber hose needs to be routed in a way that there are no sharp bends to prevent kinking.

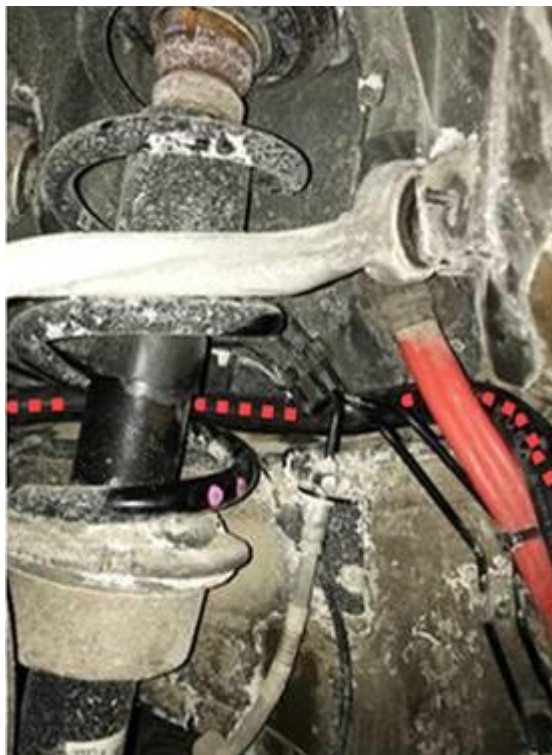
Figure 6. Routing the rubber hose.

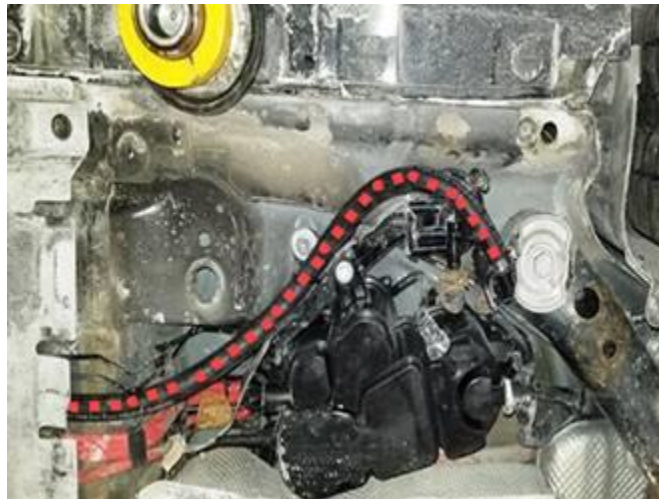
Figure 8. Connecting to the J909.

5. Before connecting 5/8" ID rubber hose to 90 degree connector, cut to length, as needed. Connection details to the J909 are shown in Figure 8 and 9.

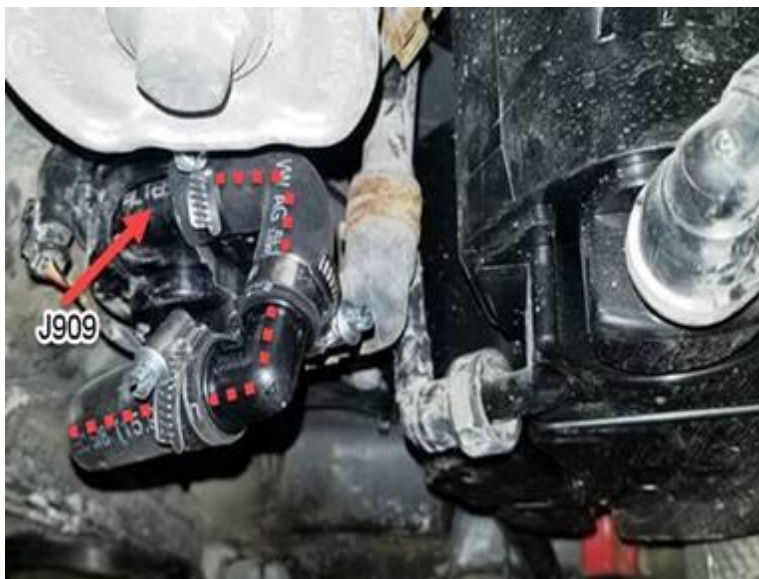
Figure 9. Closer look at the connections.

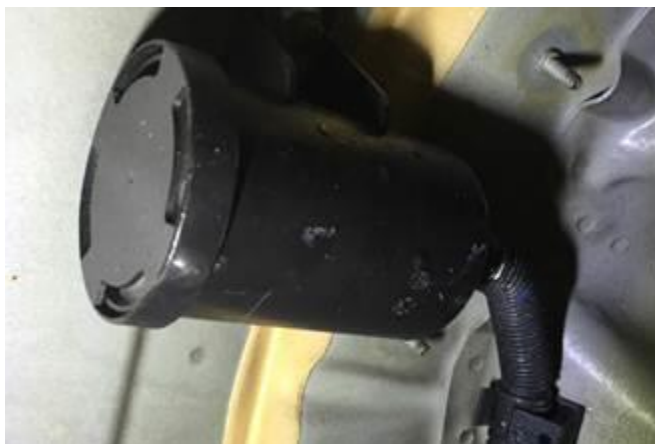
Figure 10. Remove original NVLD filter.

6. Remove original NVLD filter assembly. (Figure 10).
