SIM 51 01 20 FRONT DOORS DO NOT LATCH IN COLD WEATHER

2020-03-18

E-Series	Model Description	Production Date
F54	MINI Clubman	Up to March, 2019
F55	MINI Hardtop 4 Door	Up to March, 2019
F56	MINI Hardtop 2 Door	Up to March, 2019
F57	MINI Convertible	Up to March, 2019

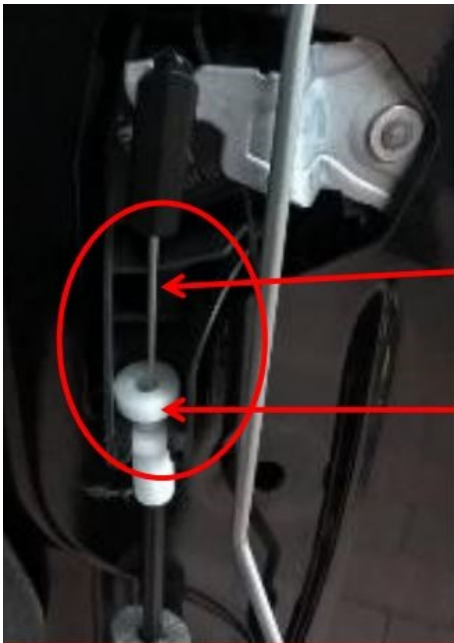
A missing seal on the inner Bowden release cable may allow water to enter the cable sheathing and freeze.

2. Visually inspect the Bowden release cable for the inner door handle of the affected door(s) for signs or water or corrosion in the area circled.

3. Are water droplets or corrosion present on the cable?

Yes: Replace the affected Bowden cable, following ISTA/AIR repair instructions for the affected door. See the note below.

NOTE: Before replacing a Bowden cable, ensure the AI number (arrow) of the replacement cable is as outlined in the table below.

Model	AI required
F54	10 or higher
F55	14 or higher
F57/F56	12 or higher
