SIM 61 01 20

## DELIVERY STOP: SAFETY BATTERY TERMINAL CONTROL LINE

This Service Information Bulletin (Revision 1) replaces SI B61 01 20 **dated February 2020**.

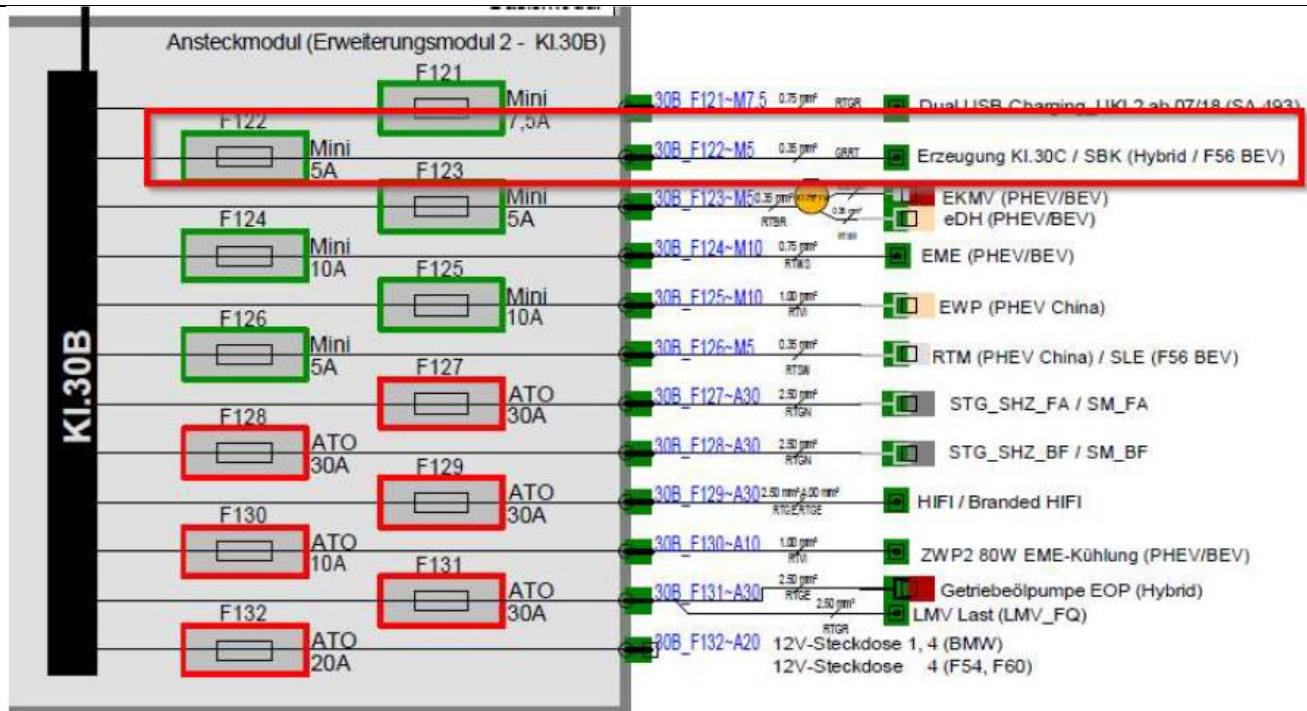
Power supply for the SBK is currently connected to fuse F122 (KL30B)

SBK power supply line needs to be extended and relocated to F113 (KL30F)
