David J. Johnson
Director
Service Engineering Operations
Ford Customer Service Division

April 3, 2020

TO: All U.S. Ford and Lincoln Dealers
SUBJECT: **Customer Satisfaction Program 20N03**
Certain 2015-2018 Model Year F-150 Vehicles
Unintended Tailgate Opening

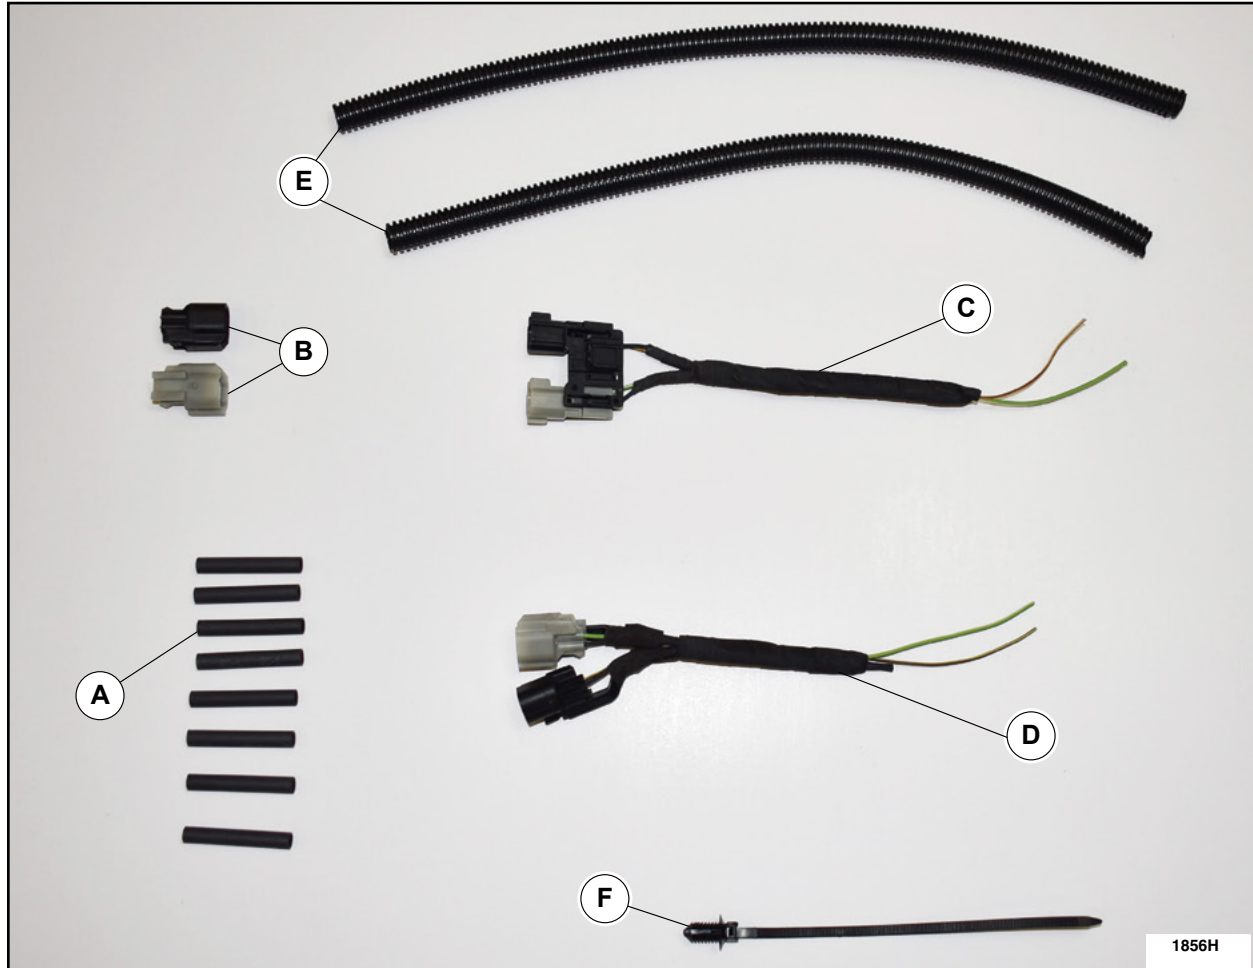
FIGURE 1

Complete Tailgate Jumper Harness Part Kit

NOTE: The parts being installed in this procedure are not labeled. Refer to Figure 1 for component identification.

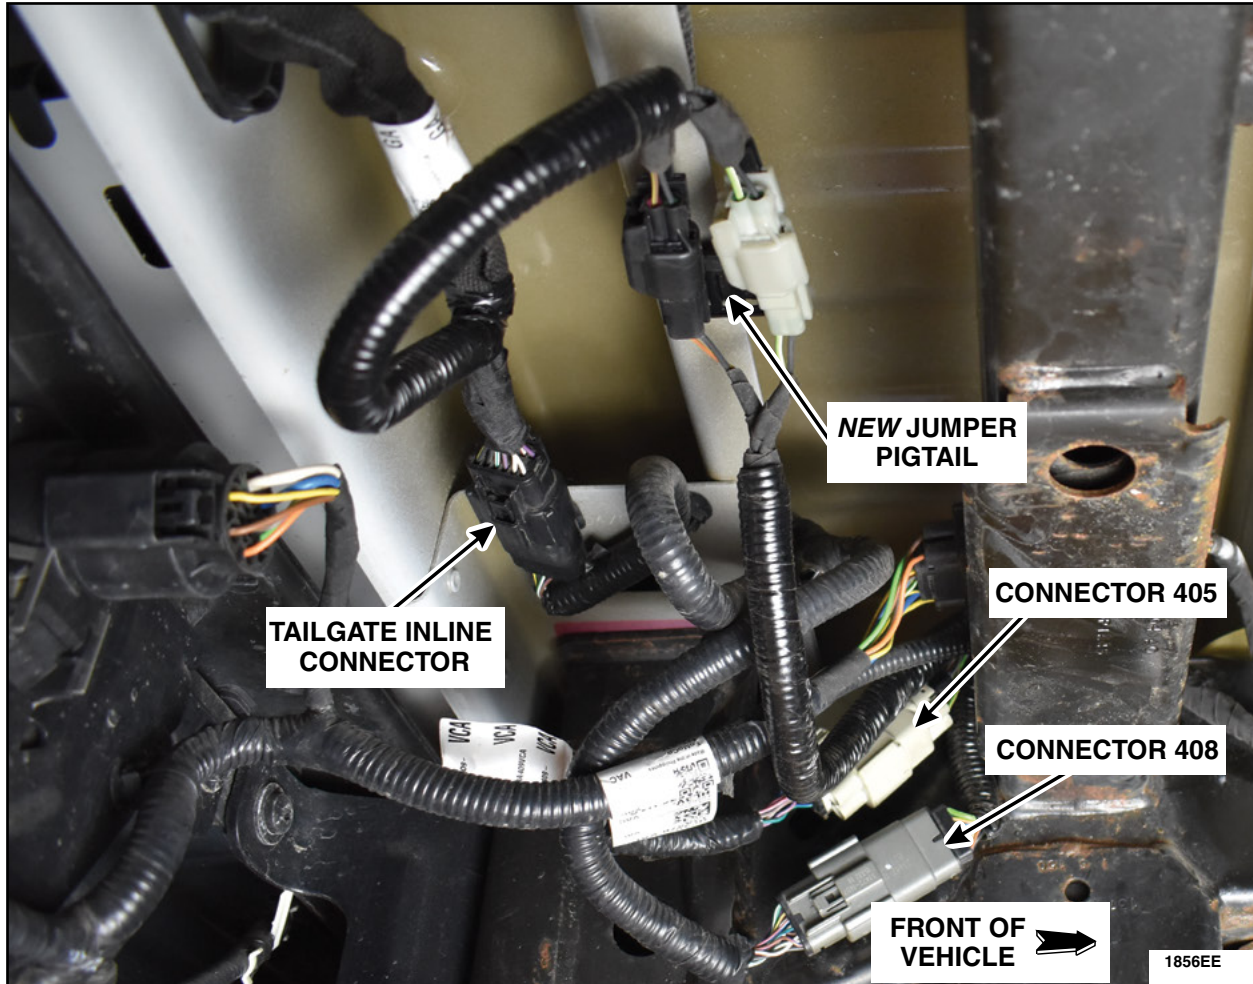
FIGURE 31

Completed Wiring Harness Modification
