Business Class M2  
> Cascadia  
108SD/114SD  
New Cascadia

**Freightliner  
Service Bulletin**

**Description of revisions:** *This bulletin replaces the version dated June 17, 2019. A procedure has been added for inspection, repair, and replacement of damaged or spun rivet nuts.*

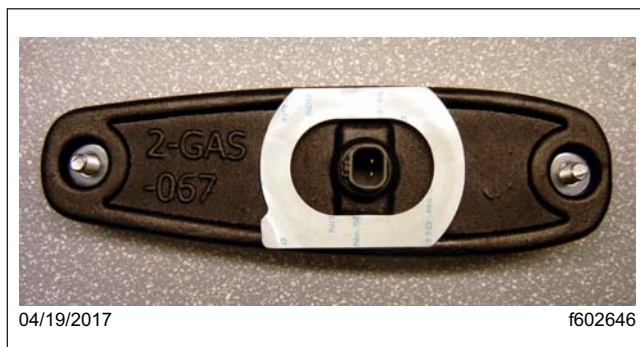
**Fig. 1, Marker Light with Peel-and-Stick Adhesive Gasket**

On November 14, 2016, the Cascadia marker light was changed in production to include an adhesive gasket. On some Cascadia vehicles built before November 14, 2016, water may intrude into the cab through the marker light gasket. If a leak is detected in a vehicle built before that date, install new peel-and-stick adhesive gaskets on all five marker lights; see [Fig. 1](#).

2. Remove the two screws that attach the marker light to the cab roof. The marker light will be reused.
3. Remove the old gasket and save it if filing a warranty claim.

4. Inspect the rivet nuts for damage, and if necessary, refer to **Section 60.05, Subject 150** of the *Cascadia™ Workshop Manual* for replacement procedures.
5. Peel the paper from the film adhesive on the lamp-facing side of the new gasket, and install it on the marker light.

6. Scrape any remaining sealant or gasket material from the cab surface, then using soapy water, clean the cab roof where the marker light will be installed.
7. Make sure the cleaned surfaces are dry, then peel the backing off the roof side of the marker light gasket.
8. Place and align the marker light and gasket on the roof.

9. To install the marker light, hand tighten the two screws that secure the marker light to the cab surface. Then, tighten the screws  $31 \pm 4.4$  lbf-in ( $350 \pm 50$  N-cm).

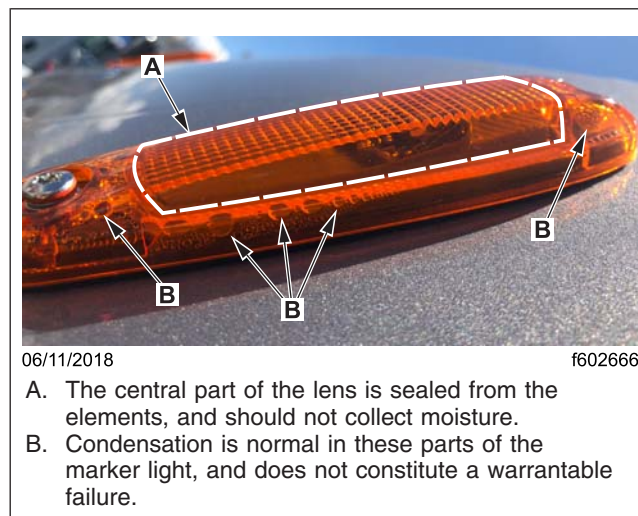
**Fig. 2, Condensation in Marker Light**

NOTE: The roof marker lights may collect moisture between certain portions of the lens and the gasket. This is completely normal and does not constitute a warrantable failure. Only the part of the lens which contains the electronics, in the center of the marker light, is sealed from the elements. See [Fig. 2](#).

A. The central part of the lens is sealed from the elements, and should not collect moisture.  
B. Condensation is normal in these parts of the marker light, and does not constitute a warrantable failure.
