LATEST VEHICLE CONCERN FIXES

Excessive Brake Caliper Assembly Lube Found At PDI

20MY Discovery Sport, RR Evoque

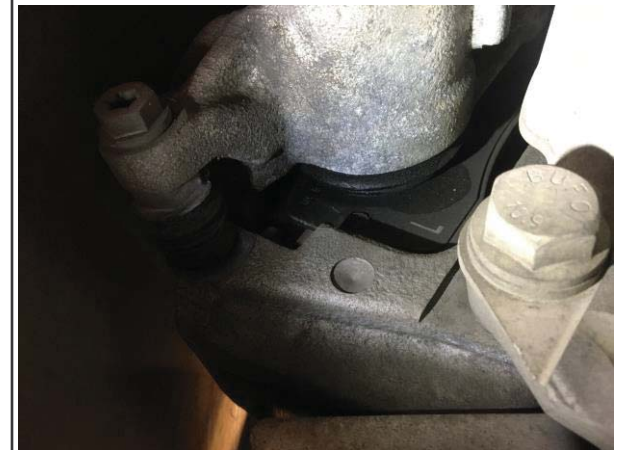
- A customer/ technician may notice what they perceive as a leak from the front brake calipers during PDI.

- An excessive amount of assembly lubricate may have been used during the assembly of the front brake calipers and as a result the extra lubricant may stain the back of the brake pad and caliper dust boot.

- The excessive lubricant does not affect brake system performance and is not a problem.
- It is advised that if this is noticed at PDI, clean the excessive lubricant with brake parts cleaner and a rag then road test the vehicle and recheck for any leaks to ensure that staining in this area was only excessive assembly lubricant.
