Technical BULLETIN

CERTAIN 2018~2019 XSR700 AND MT-07 Drive Chain Guard Noise

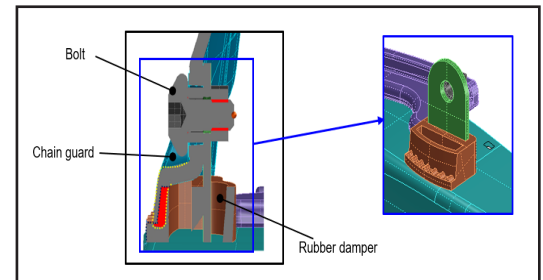
Problem: The drive chain guard rattles while riding.

Cause: There is a gap between the drive chain guard and rear arm bracket even when the mounting bolts are tightened. This allows the drive chain guard to move and make a rattling noise due to engine vibration and road conditions.

Remedy: To prevent the rattling noise the factory has developed a rubber damper to absorb the drive chain guard vibration.
