SERVICE BULLETIN

APPLICABILITY: 2019-20MY Ascent NUMBER: 12-286-20

SUBJECT: Front Door Weatherstrip- Design Change **DATE:** 04/06/20

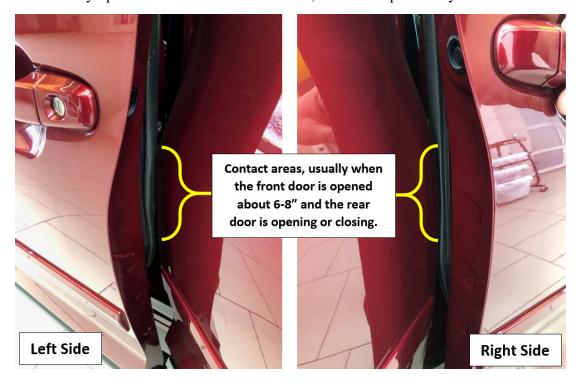
This bulletin announces a design change made to the front door weatherstrips to prevent interference with the leading edge of the rear doors under certain circumstances. This condition can happen when the "timing" of opening both front and rear doors occurs at the same time and in the right sequence. If one door is fully opened or closed before the other, there is no possibility of contact.

The new front door weatherstrips were incorporated into production starting with VIN L3454488.

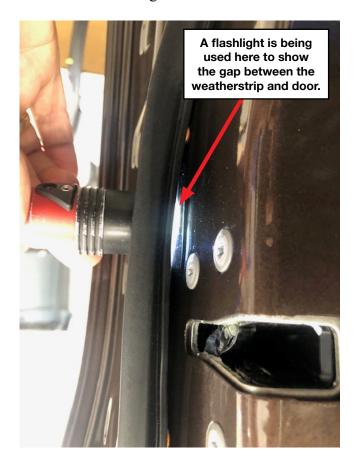
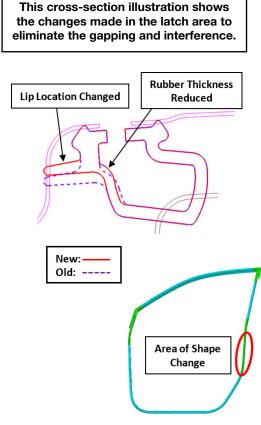
The new front door weatherstrips were changed in the potential contact area. The changes eliminate the gapping shown below and provide additional clearance needed to prevent the interference with the rear door's front edge.

The new front door weatherstrip part numbers are:

- Right Front- 63511XC00B
- Left Front- 63511XC01B
