MODEL
2014MY
Sorento (XMa)

NUMBER
057 (Rev 3, 09/11/2014)

TECHNICAL SERVICE BULLETIN

SUBJECT: SERVICE ACTION: BCM UPGRADE - IPM TO
IMPROVEMENT (SA163A)

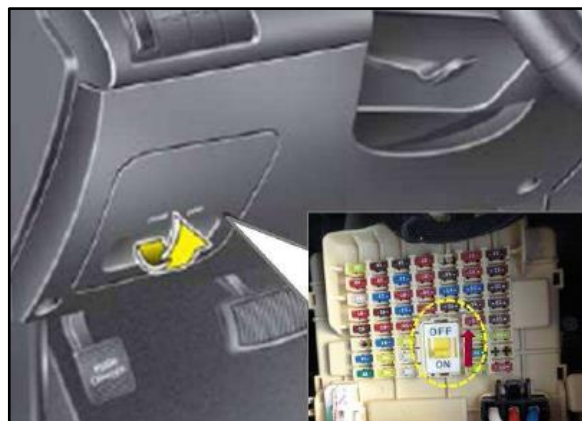
Before performing the manual update, cycle the fuse box panel power switch to the **OFF** position for **20 seconds**. Then, cycle the fuse box panel power switch back to the **ON** position.

1. Within the ECU Upgrade screen, select **Manual Mode** in the left column, select **BCM** and then select **Upgrade Event 225**. Select the appropriate control unit part number by referring to the ROM ID Information Table on Page 2, and click **OK**.
2. Enter the appropriate password from the table above, and click **OK**.
3. Cycle the ignition ON and OFF once and open the driver's door, when prompted. Then, click **OK**.
4. Upgrade will begin and the progress of the upgrade will appear on the bar graph.
5. Click OK on the final screen. Upgrade event 225 is now complete.
6. Reconnect the hood switch
7. Operate the tailgate to confirm proper operation.
