Technical Service Bulletin

Topic	V8T- Oil leak between engine and gearbox
Market area	Bentley: worldwide (2WBE),Hongkong-Macau (5HK)
Brand	Bentley
Transaction No.	2042494/4
Level	EH
Status	Released for publishing
Release date	Apr 16, 2020

Continental and Flying Spur equipped with V8T engine

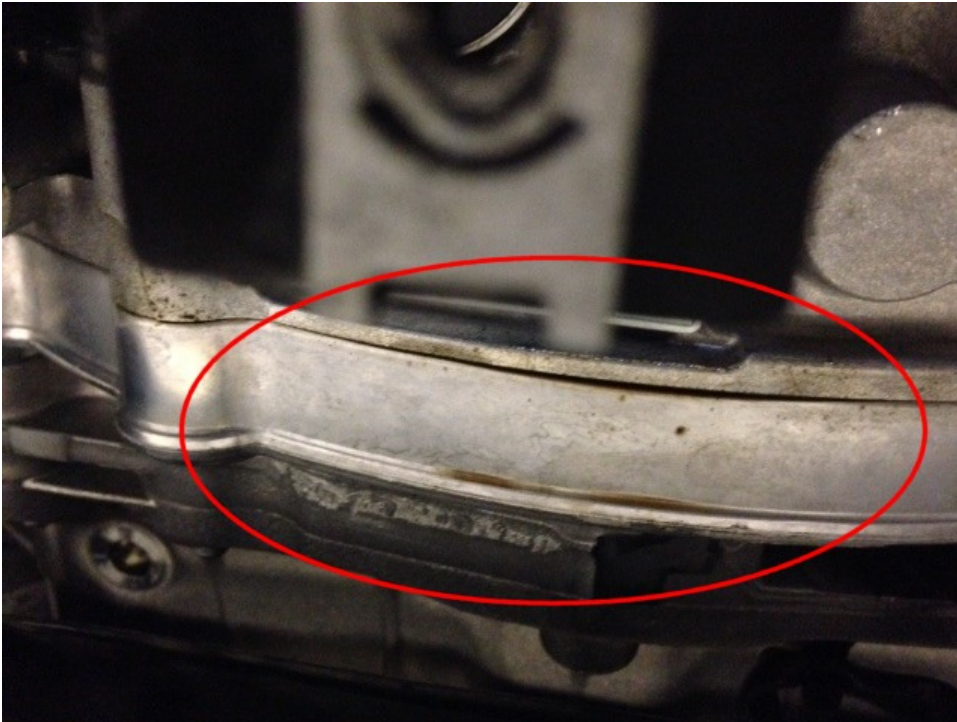
Figure 1

Oil is evident at interface between the engine and gearbox (see Figure 1)

Identify precisely the source of the oil leak. If necessary photograph the area then, clean the engine and reassess the vehicle after a test drive (see Figure 1)

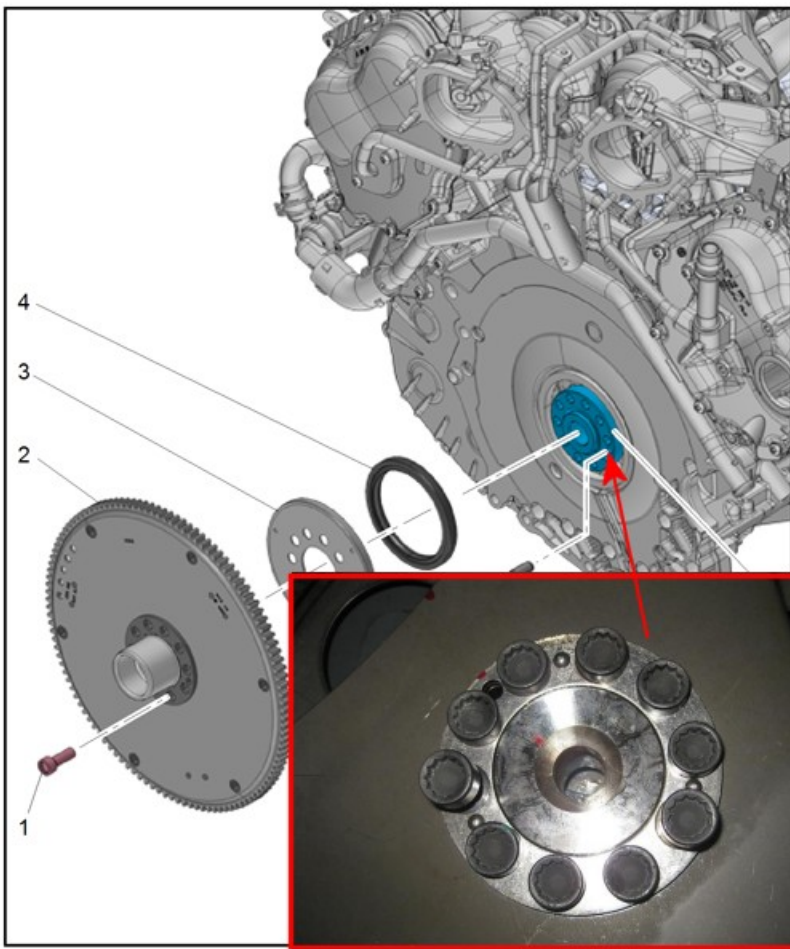
Figure 2

Oil loss via thread of fasteners in crankshaft used to attach torque convertor drive plate/flywheel. New bolt specified with thread sealer pre applied, part number WHT005487A.

This TPI is to be used to remedy oil found to be leaking through the threads of the fasteners (1) securing the flywheel/flex plate (2) to the rear of the engine crankshaft (see Figure 2)

1. Once it is identified that the oil is originating from inside the bell housing then remove the engine and gearbox and flywheel/flex plate Ref workshop manual Rep.Gr13 – Flywheel – To remove and fit.
