Articles Contained in this Issue

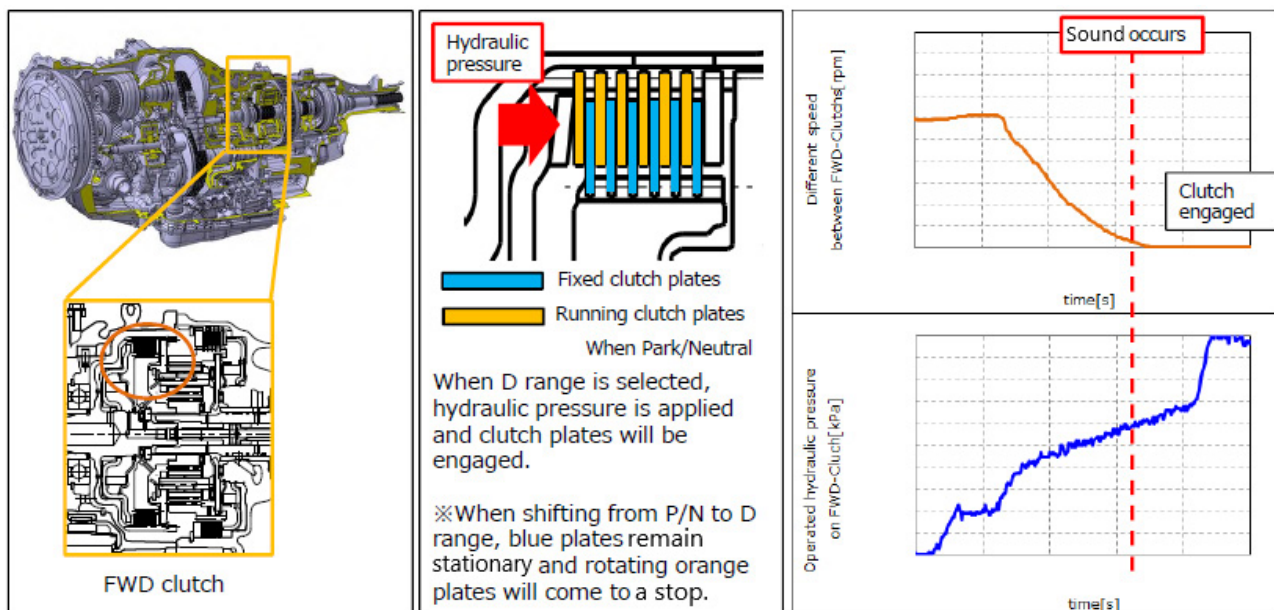
The High-Torque CVT equipped in the 2019+MY Ascent, 2015+MY Legacy/Outback 3.6R and XT, 2014-2018MY Forester XT, and 2015MY+ WRX (CVT equipped), may emit a brief squeak or chirp sound when shifting the transmission from park or neutral to drive. This sound is caused by the operation of the forward clutch, just before the clutch fully engages. The sound is caused by the clutch plate friction materials sliding against each other. These plates are designed to accept this type of contact. The sound does not affect the performance or reliability of the transmission and is characteristic of its operation so, no attempt should be made to try to repair it. It is important to ensure there are no DTCs stored as current or in history, there are no drivability concerns present and, the sound only occurs while the vehicle is stopped and under the conditions described above.

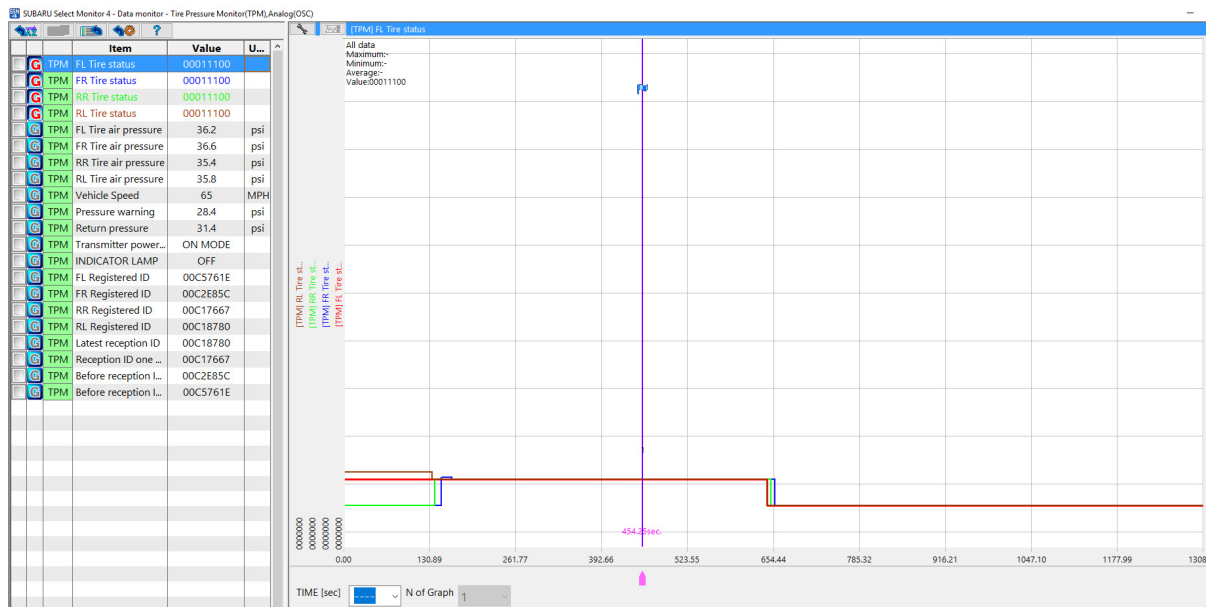
Below is a SSM4 graph of normal operating sensors for reference:

Take note, the sensors are reading the same status and are uniform.

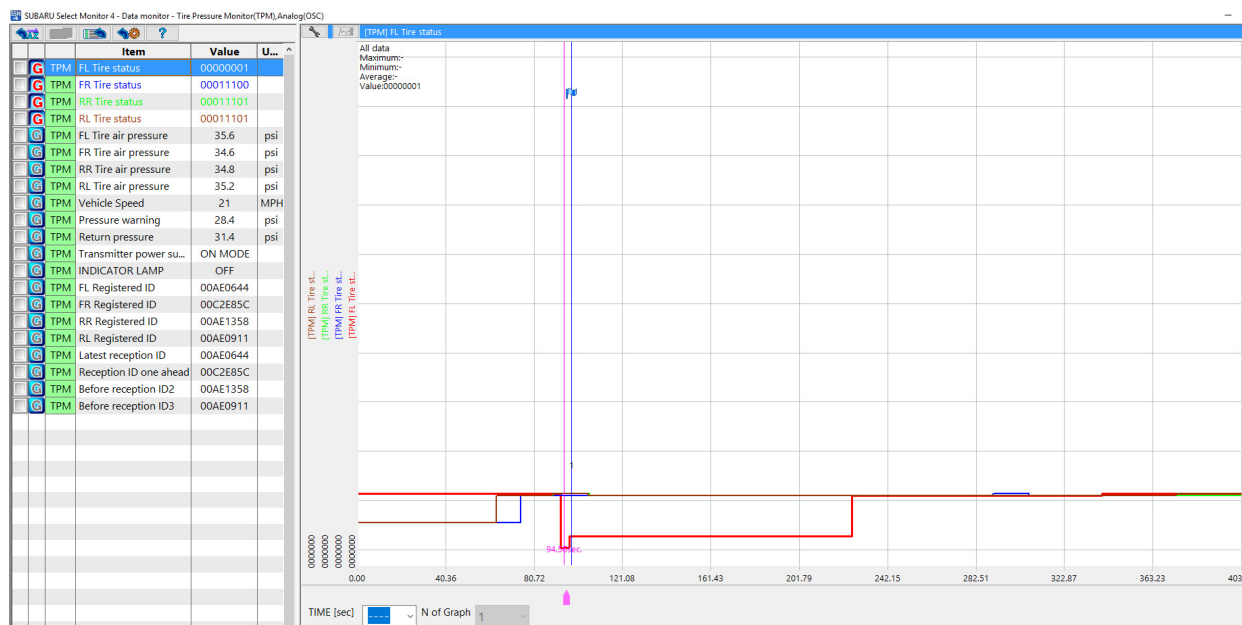
Below is an example of a faulty TPMS sensor:

In the picture above, you can see one of the sensors does not communicate properly and drops status. The other sensors change status as designed and eventually the faulty sensor comes online. This would be a case of intermittent transmission. This will aid in diagnosis to isolate the potential faulty sensor.

Once a sensor is isolated, the wheel and tire should be swapped with a known good assembly for testing. Do not neglect to register the sensors before performing another test drive. The BIT/live data should then be monitored again for any fluctuations.

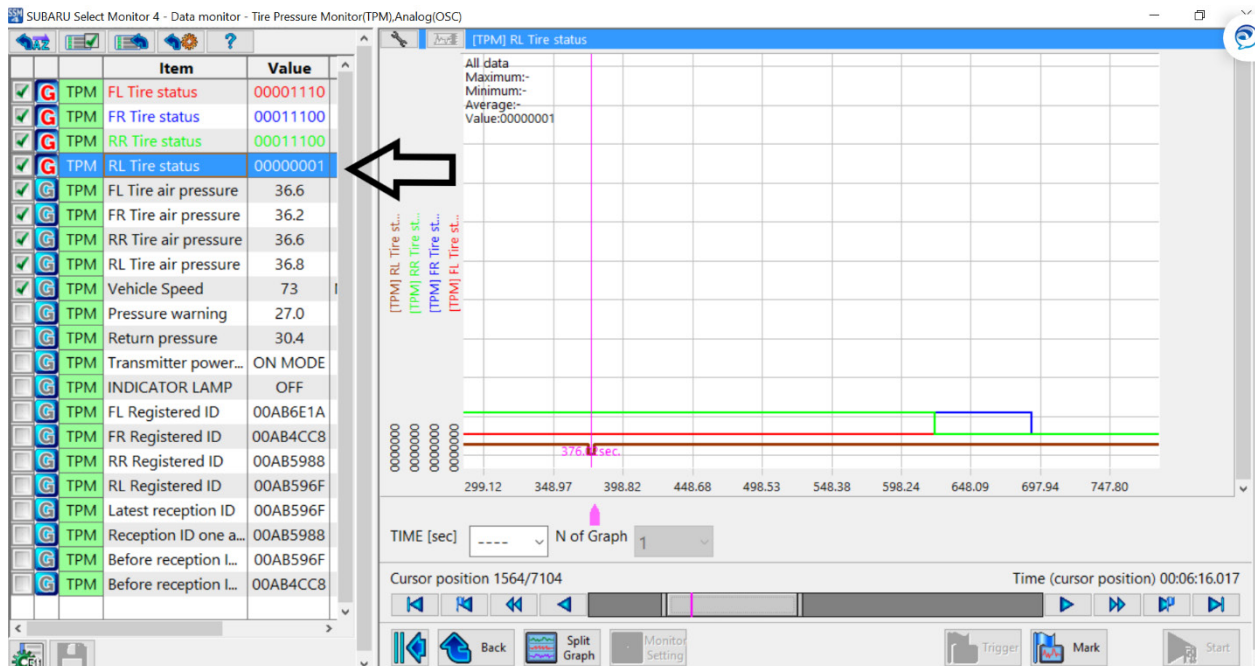
Above is another example of a faulty sensor.

A transmitter code may be set if the individual tire pressure sensor malfunctions multiple times in correspondence with TPMS CM logic. This should be considered when determining which of the sensors may be malfunctioning.

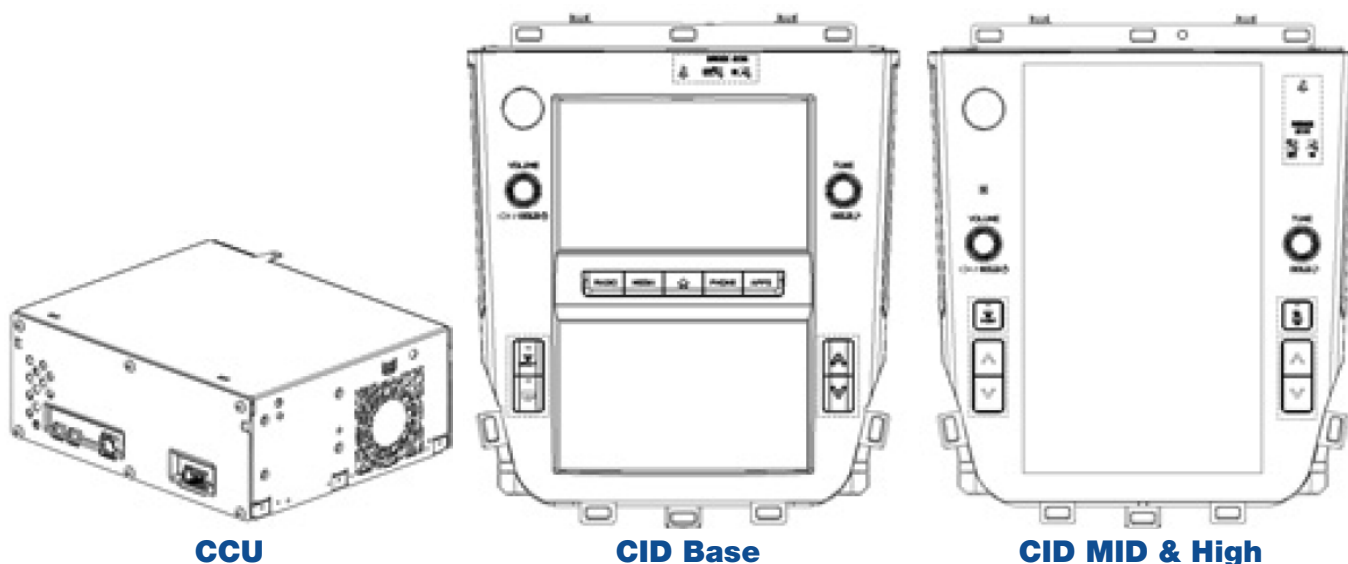
There is currently a high volume of exchange orders for Denso CP1 CID components.

In the vast majority of cases, even when the operation of the CID touch screen appears impacted (stuck, frozen or not responding), this is actually a result of a CCU software or hardware failure rather than actual CID failure. CCU is either unable to receive the input properly or unable to provide the needed output to display but, the touch screen is still functioning as designed. Moving the affected CID to a correctly operating vehicle is a quick way to confirm the CID is or is not related to the condition.

In order to mitigate the risk of backorder situation, always insure proper diagnosis is completed each and every time prior to proceeding with CID or CCU exchanges. The results of diagnostics performed must be documented on the Repair Order and in the rare case of an actual CID failure, using the supplied questionnaires attached to QMRs.
