SERVICE INFORMATION

APPLICABILITY: All Models with STARLINK Telematics System **NUMBER:** 15-195-16R
SUBJECT: Servicing and Claim Submission Requirements for STARLINK Diagnosis and Repair Involving the Data Communication Module (DCM) **DATE:** 04/28/20
REVISED: 04/30/20

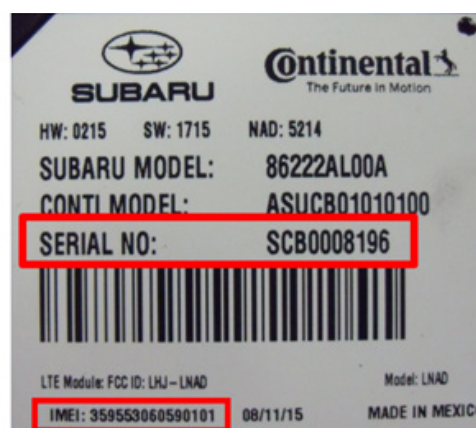
5) Effective Immediately, all claims for DCM replacement MUST include the 10-digit DCM Serial Number of the installed (new) DCM. This number is found on the DCM label shown here and MUST be entered in the Miscellaneous Detail field of the claim entry.
