SERVICE BULLETIN

APPLICABILITY: 2018MY Legacy and Outback
 2018MY Crosstrek
 2017-18MY Impreza
 2018MY BRZ
 2018MY Forester

NUMBER: 15-263-20

SUBJECT: Harman Gen. 3.0 Audio and Navigation - Equipped Head Unit Warranty Extension

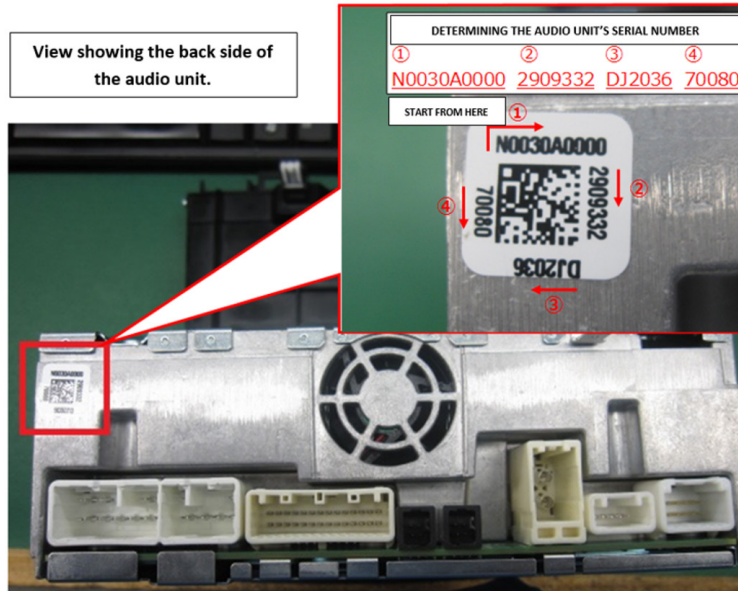
- Before installing the exchange H/U, look for a small sticker with a QR code on the back side, upper left corner of the H/U. This QR code is surrounded by 4 numeric segments, together making up the Serial Number of the H/U. Record the 4-part Serial Number as shown below on the Repair Order. The H/U Serial Number is to be entered into the Claim Comments field at Claim entry.
