## SERVICE BULLETIN

**APPLICABILITY:** 2020MY BRZts / Tuned by STI Model

**NUMBER:** 05-74-20

**SUBJECT:** Knocking -Type Sound from Engine Compartment

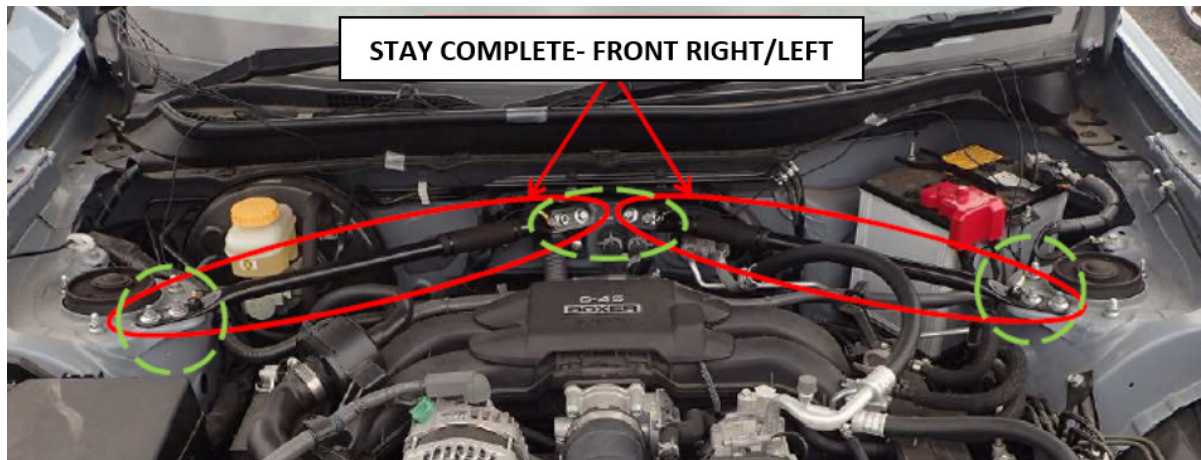
This bulletin provides a service procedure to address a small number of customer concerns regarding a knocking -type sound coming from the engine compartment when going over bumps at low speed. The sound is a result of foreign material trapped between the attachment surfaces of both stays and the toe board bracket and strut tower. The stays are identified in the red call-outs below and the mounting points in green.
