# Technical Service Bulletin

<b>Subject:</b>  MIL ON WITH DTCs P1285, P1299, P0128, P0300, P0301, P0302, P0303, P0304, P0316	<b>Bulletin No.:</b> 01-005/20
	<b>Last Issued:</b> 04/01/2020

2010-2011 Tribute 2.5L

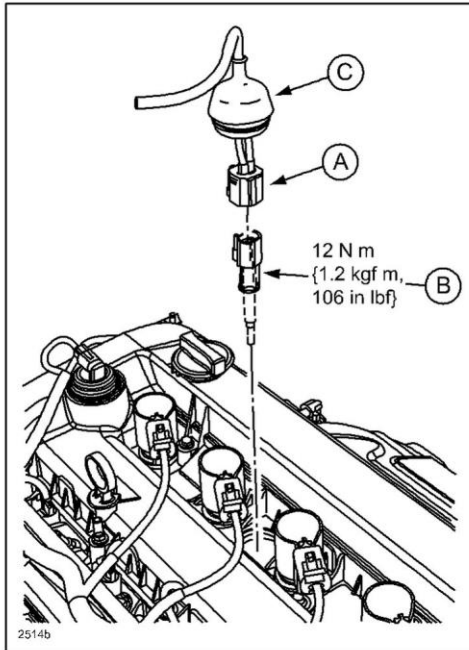
Engine temperature concerns may be due to corrosion at connector 0140-119 (A). Refer to MGSS online (CONTROL SYSTEM - 2.5L).

1. Inspect the cam cover trough, making sure it is clear of debris like leaves, wasps, dirt and the drain hole by cylinder 4 is open.

2. Inspect connector 0140-119 (A) at cylinder head temperature (CHT) sensor (B) for evidence of water contamination.

3. If corrosion from water contamination is severe and terminals are rusted and disintegrated:

a. Cut off connector 0140-119 (A) and install a new pigtail connector. Refer to instruction sheet.

b. Replace the CHT sensor (B). Refer to MGSS online (CYLINDER HEAD TEMPERATURE (CHT) SENSOR REMOVAL/INSTALLATION - 2.5L).

**NOTE:** If corrosion is not severe, remove any water and thoroughly clean connector 0140-119 (A) and the CHT sensor (B)
