Subject: FRONT DOORS DO NOT LOCK WHEN USING TOUCH SENSOR	Bulletin No.: 09-016/20
	Last Issued: 04/17/2020

2019-2020 Mazda3 (Japan Built) vehicles with VINs lower than JM1BP*****169827 (produced before Feb. 13, 2020)

2019-2020 Mazda3 (Mexico Built)

2020 CX-30

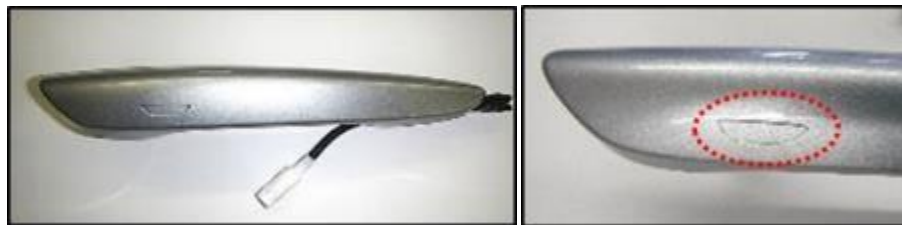
Some customers may find that they cannot lock their vehicle when using the touch sensor (shown below) on the front door handle, however, they can unlock the vehicle. This concern may occur after the vehicle has been recently washed and water has accumulated around the touch sensor, resulting in temporarily lowering the sensitivity of the capacitive sensor. To eliminate this concern, the shape and material of the rubber sheet attached to the touch sensor has been improved.

Customers having this concern should have their vehicle repaired using the following repair procedure.
