Technical Service Bulletin

Subject: POWER LIFTGATE (PLG) DOES NOT CLOSE WHEN PRESSING REAR LIFTGATE SWITCH	Bulletin No.: 09-019/20
	Last Issued: 04/29/2020

2017-2020 CX-5

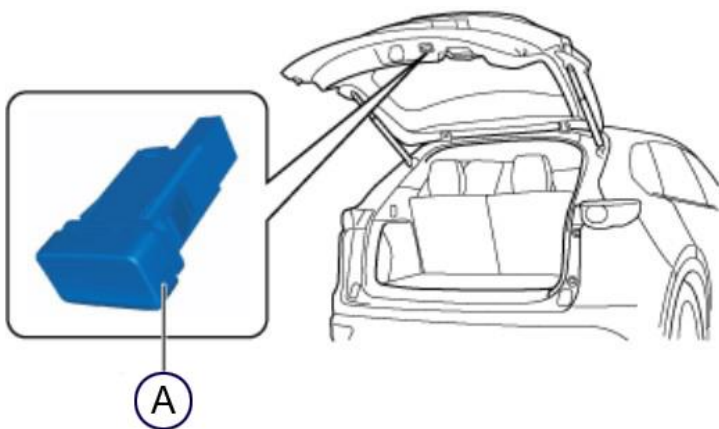
Some customers may find that the liftgate does not close when pressing the power liftgate (PLG) rear switch (A) located on the interior liftgate trim. This may be caused by PLG switch corrosion. Water from condensation may drip onto the switch connector and cause corrosion.

1. Verify the customer concern.
2. Remove the rear power liftgate switch according to the instructions on MGSS online POWER LIFTGATE (PLG) REAR SWITCH REMOVAL/INSTALLATION.
3. Inspect rear power liftgate switch. Is rust/corrosion found?
 - Yes - Replace the rear power liftgate switch, then go to Step 4.
 - No - Go to Step 4.
