SAFETY RECALL NOTICE

Subject: **Can-Am® Spyder RT – Emergency Braking Situation: Possible Sudden Loss of Brake**

Campaign no.: 2020-0007

No. **2020-5**

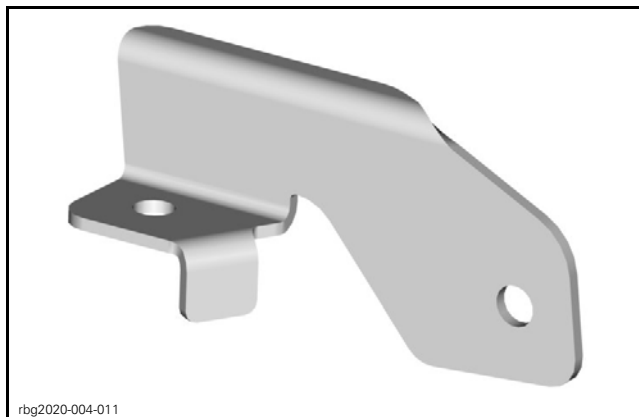
In emergency braking situations, the support which holds the brake mechanism could break and cause a total loss of braking capacity. This may increase the risk of a crash.

Install a bracket to secure the brake mechanism to the rear footrest support.
