Service Alert

Subject: "IN-VEHICLE NETWORK MALFUNCTION" INSTRUMENT CLUSTER WARNING MESSAGE	Service Alert No.: SA-029/20
	Last Issued: 04/08/2020

2019-2020 Mazda3
2020 CX-30

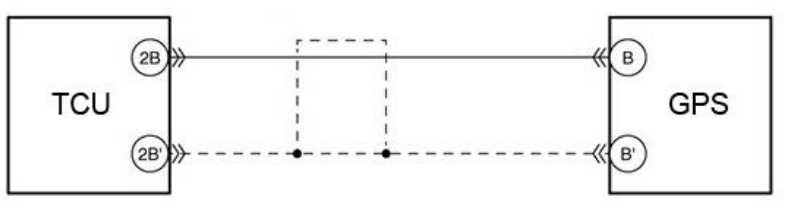
DTC	Action
B119F:01	<p>1. Check GPS antenna connection.</p> <p>1. GPS connection is good - No further repairs needed. TSB repair is coming soon. Inform the customer that Mazda is aware of the issue and is working on a repair. Release the vehicle to the customer.</p> <p>2. GPS connection is bad - Repair GPS antenna connection.</p>

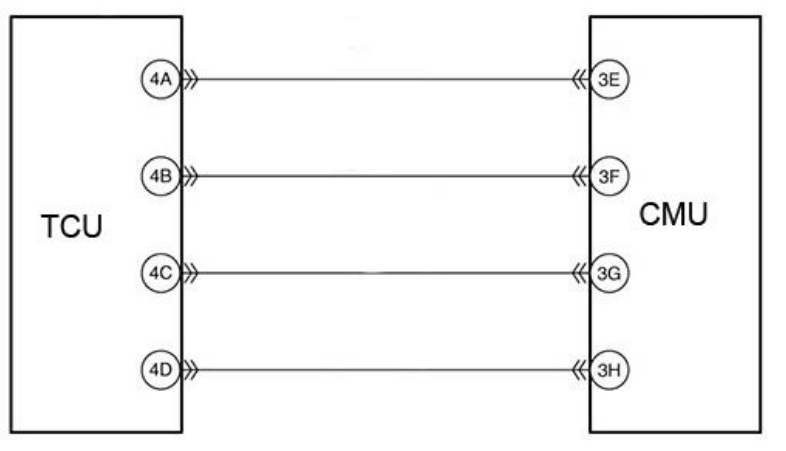
B1252:87	<p>1. Check USB cable connections between TCU and CMU.</p>
