# WARRANTY BULLETIN QUALITY

Campaign no.: 2020-0006

Subject: **Spyder® RT - Abnormal Gaps Around the Rear Cargo Module Access Covers**

No. **2020-4**

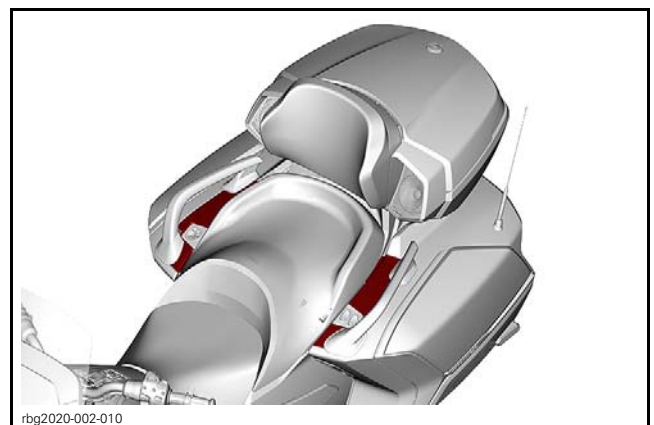
rbg2020-002-010

On some Spyder RT manufactured since February 6<sup>th</sup>, abnormal gaps may be present between both rear cargo module access covers and adjacent body parts.

Replace both access covers.

1. Remove the passenger seat.
2. Remove and keep both screws securing the access cover.
3. Remove and discard the access cover.
4. Position the access cover and loosely install the previously removed screws.
5. Move the access cover to have an equal gap in back and in front.
6. Hold the access cover in this position and tighten screws.

TIGHTENING TOQUE	
Access cover screws	2.75 N•m ± 0.25 N•m (24 lbf•in ± 2 lbf•in)

7. On the other side of the vehicle, repeat steps 2 to 6.
8. Reinstall the passenger seat.
