Subject: CONNECTED VEHICLE SYMPTOM TROUBLESHOOTING	Service Alert No.: SA-031/20
	Last Issued: 04/14/2020

2020 CX-30

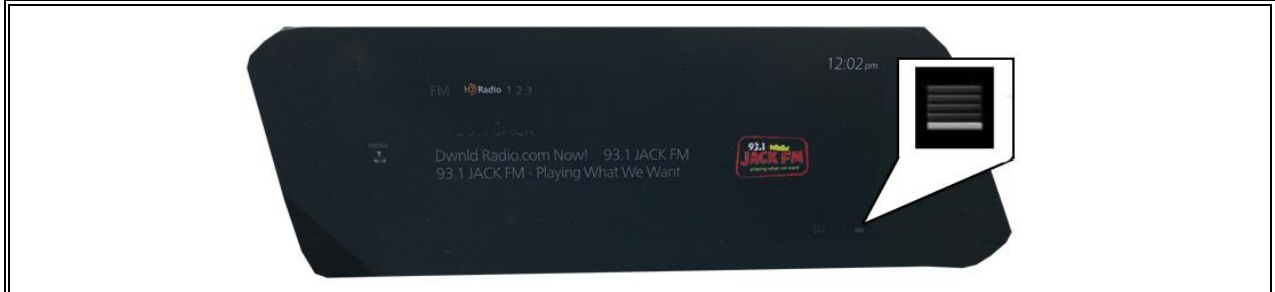
Confirm the customer's phone and vehicle have good to strong reception during the concern as shown in the table below.

Indication	Explanation
	Radio waves are not being received. Move to a location with good reception.
	Weak reception.
	Good Reception
	Strong reception.
	Currently conducting an operation check of the communication unit. If this condition continues, consult an Authorized Mazda Dealer.
	The communication unit is unsubscribed or a Connected Service contract has ended.

- If the reception is weak, move the vehicle to a location where the reception is good to strong as shown in the table, then try to get the One Time Pass Code and/or operate the remote functions before proceeding to the Repair Procedure if there is still an issue.
- If the reception is good to strong, proceed to the Repair Procedure.
