WARRANTY BULLETIN

Campaign no.: 2020-0005

Subject: **Spyder® RT - Abnormal Gaps Around the Rear Cargo Module Access Covers**

No. **2020-3**

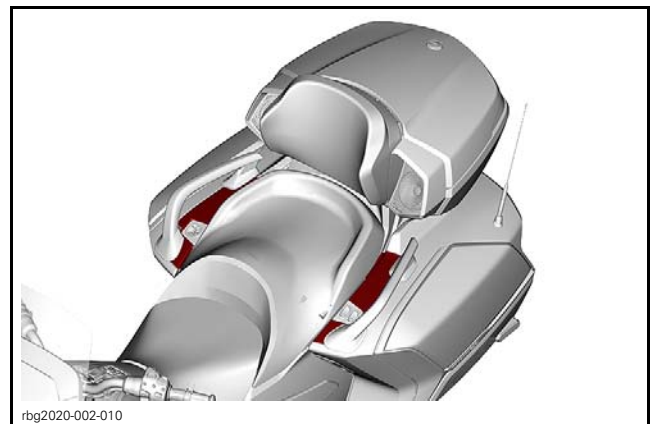
The interference between access covers and frame prevent mounting holes alignment. This situation creates abnormal gaps around both rear cargo module access covers.

Abnormal gaps are present between both rear cargo module access covers and adjacent body parts.

Replace both access covers and install screws instead of the locking ties.

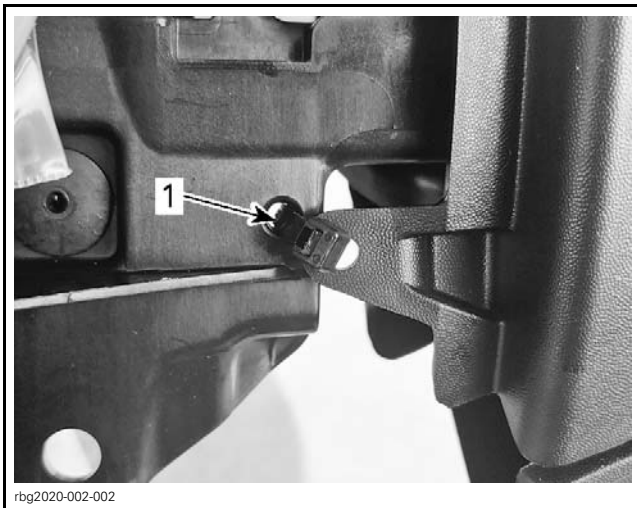
1. Locking tie

To minimize the gaps, only the access cover rear screw was installed from factory.

The front was intentionally secured with a locking tie instead of a screw.
